Odds On Home Inspection Services

Home Inspection Report

1234 Mock Street , calgary, Alberta

Date of Inspection: 4/17/2014 Time: 4pm
Age of Home: 2004 Size: Approx 2400 sq ft
Weather: Cool - Cloudy

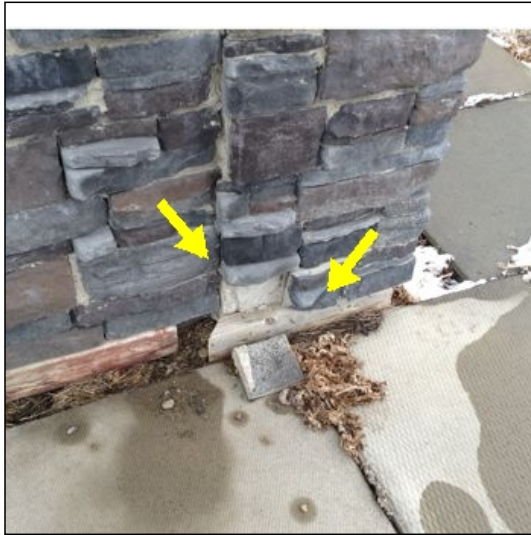
- Higher levels of wall clad around the home are only visually inspected from the ground level.
- Areas of minor damage noted.

Minor clad repairs required

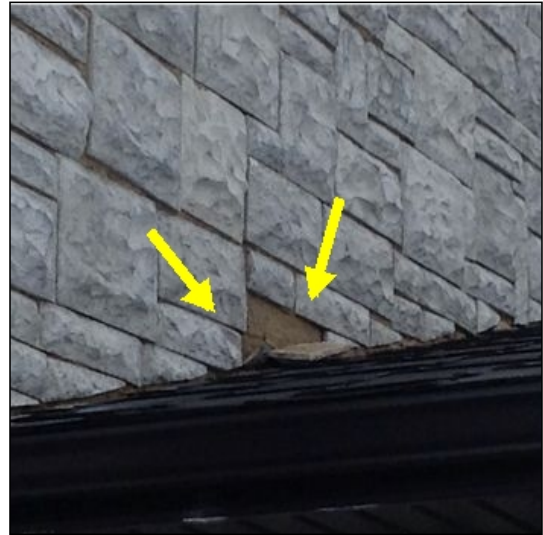
Attach trim as required

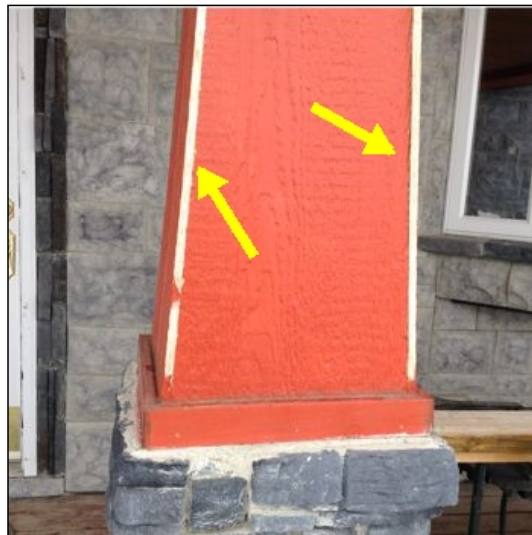
Scrape and repaint as required

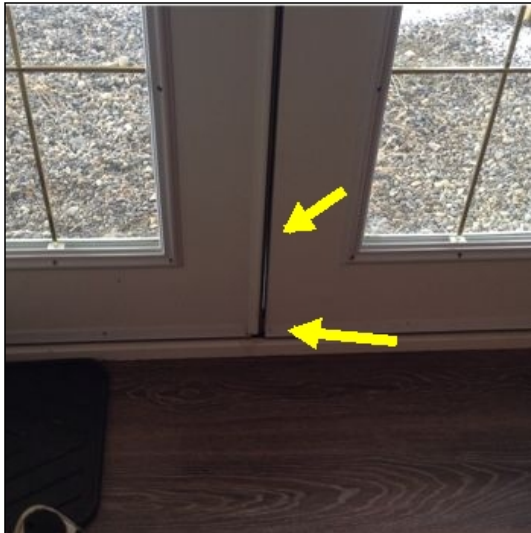
Replace weatherstripping to reduce heat loss at exit doors

- Highly recommend replacing all weatherstripping and door sweeps, if and when required to reduce heat loss in the home.
- Adjusting lock sets at exit doors will allow the door to pull tighter to the weatherstripping reduce heat loss during the winter months.

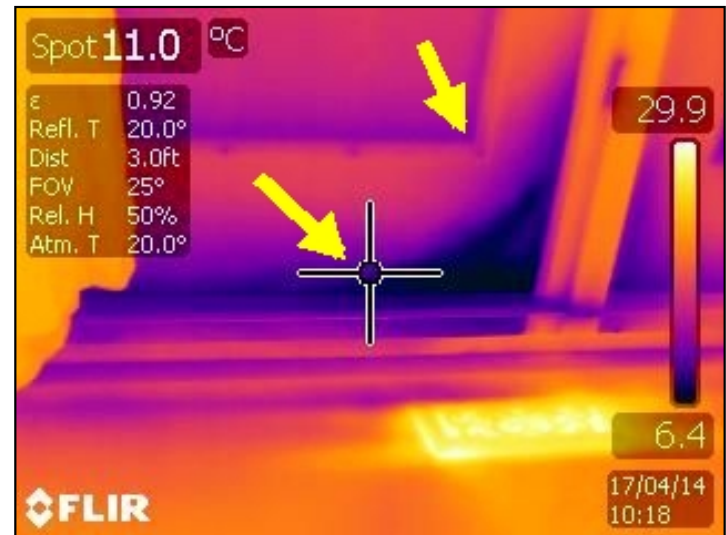
Heat loss at exit doors due to poor weatherstripping

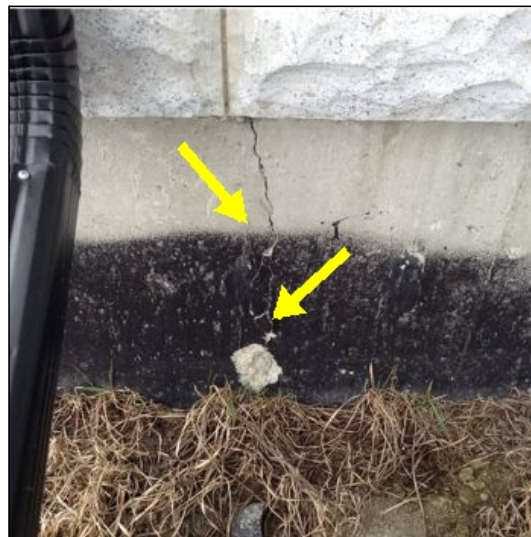
- Cement parging is flaking/deteriorated, this is extremely common and decorative but suggest review for repair as necessary to protect the foundation wall from premature aging.
- Common cracks noted - Most vertical cracks in a foundation wall do not seriously damage the structure of your home. Vertical cracks are most often caused by the shrinkage of the concrete as it cures, but they also tend to occur from damage as the foundation settles. The more significant problem in this case is that you are now vulnerable to water seeping into your basement, we suggest sealing to prevent this, but should this cracking appear to worsen, consultation with a qualified contractor for required repairs is recommended.

Common shrinkage cracks noted

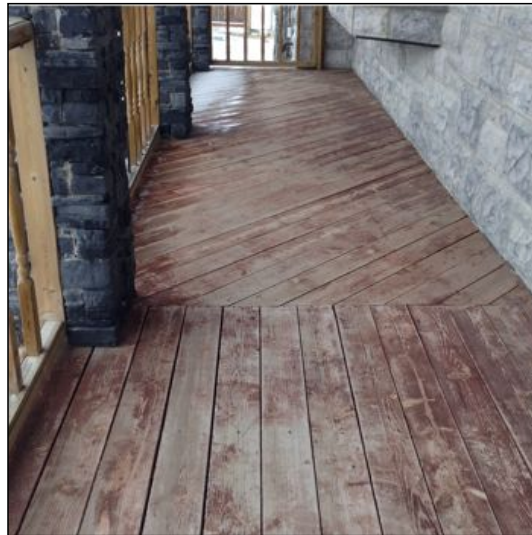
- Porch is weathered, suggest cleaning, as necessary, and treating with an oil based, water-repellent preservative to protect and extend the life of the wood.

Re seal porch

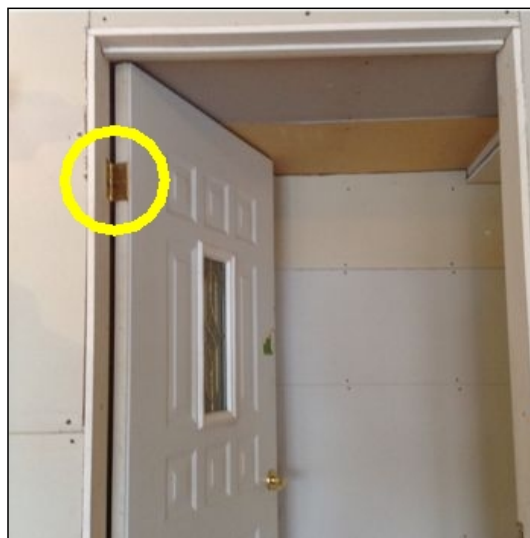
- The fire door should automatically close, if it does not as required this is deemed as a safety hazard, suggest adjusting to do so ASAP.
- No self closer. Recommend installation of self closer to protect against fume entry.

Door into garage should self close for safety

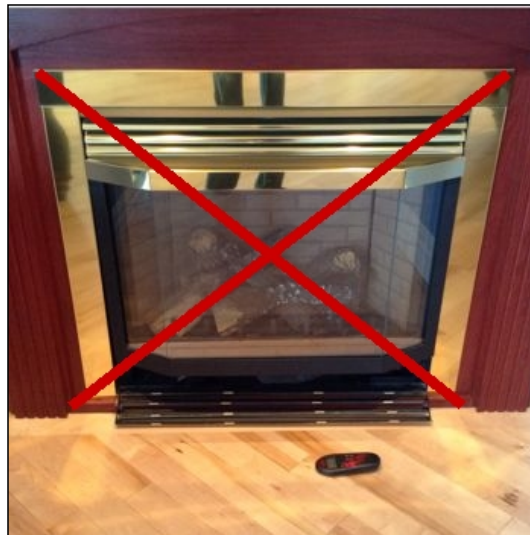
- **Not operational - Recommend further review and cleaning by a qualified professional prior to use.**

Fireplace requires attention

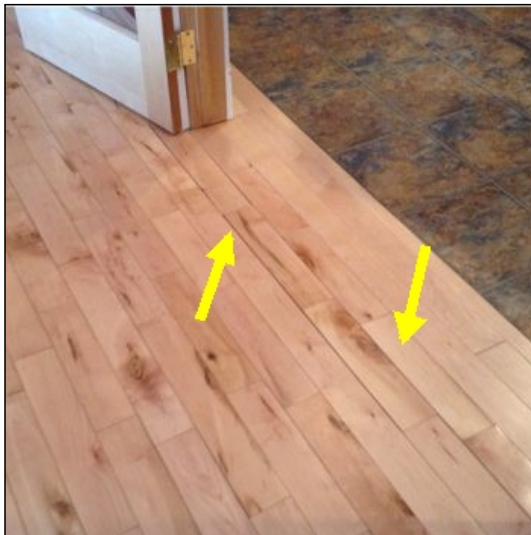
Separation noted on dining area - No humidifier will not help

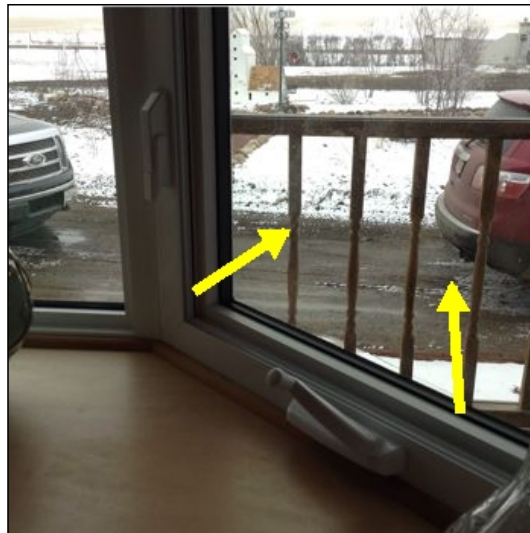
- Windows are opened and tested to ensure they work as required. All good on day of inspection.
- Missing screens observed.

Some screens missing around the home

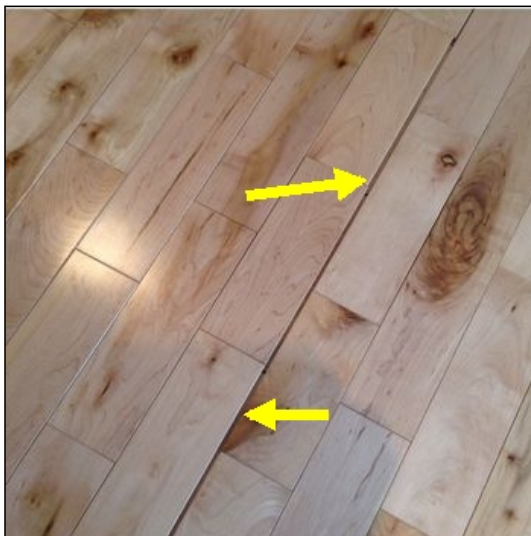
Slight floor separation noted in bedroom 2

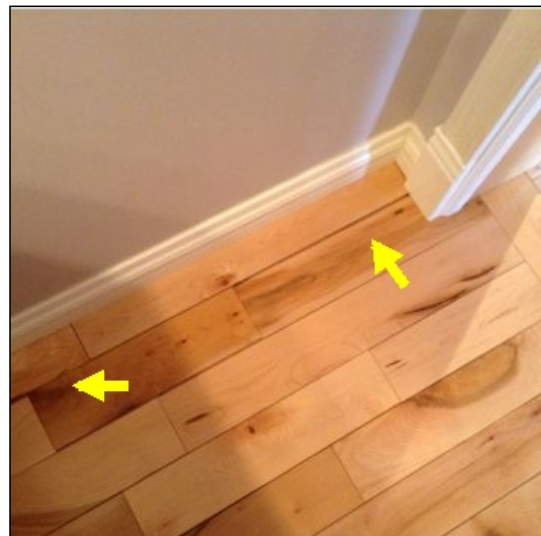
Slight separation in en suite 3

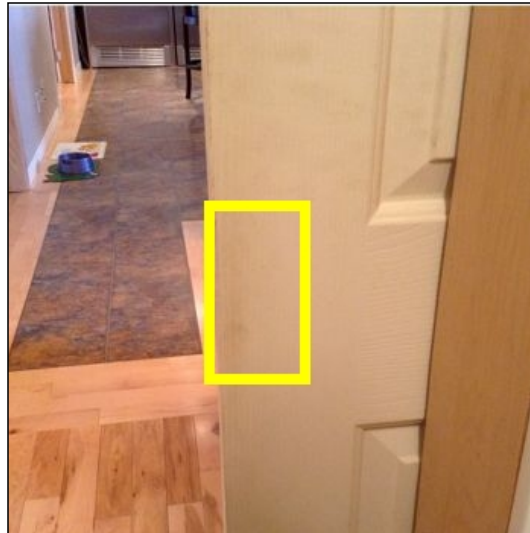
Handle required at en suite pocket door

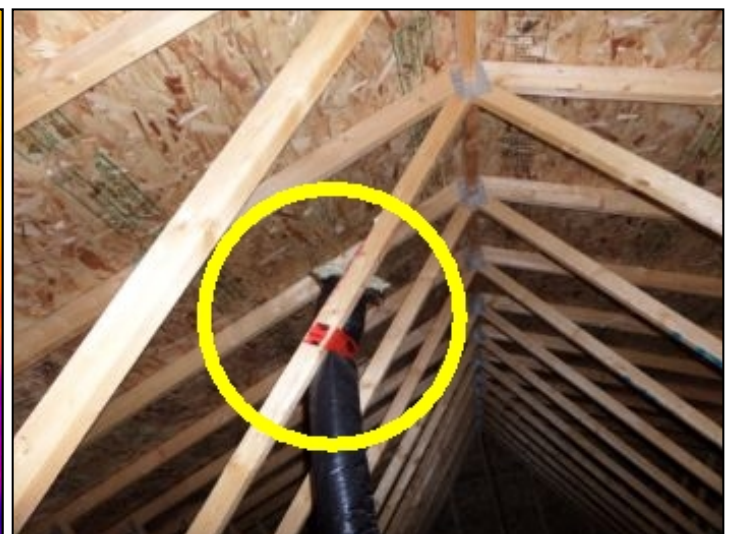
exhaust fan is vented into attic area - must vent externally

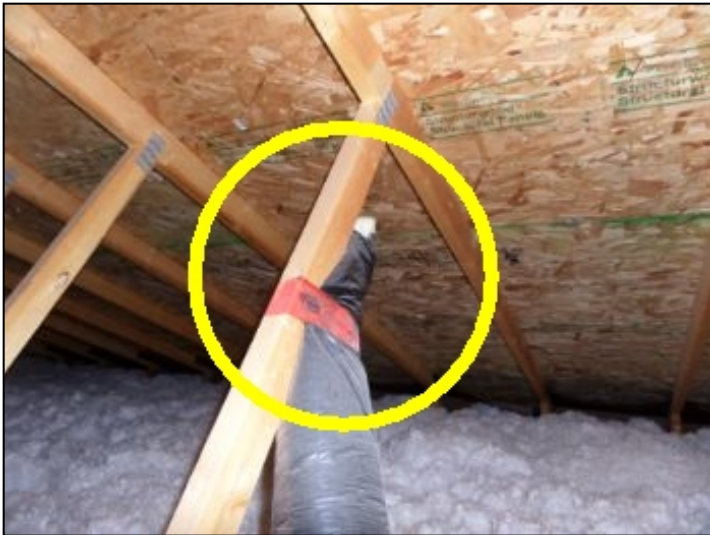
In correct venting can cause moisture and mold issues

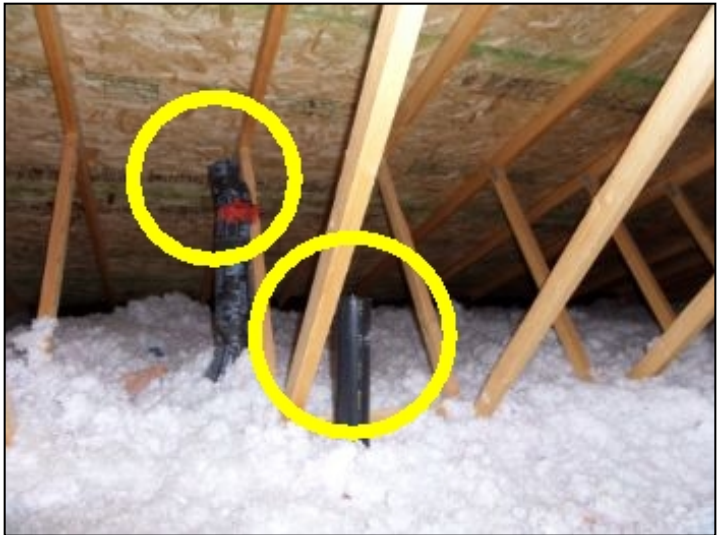
Should be externally vented

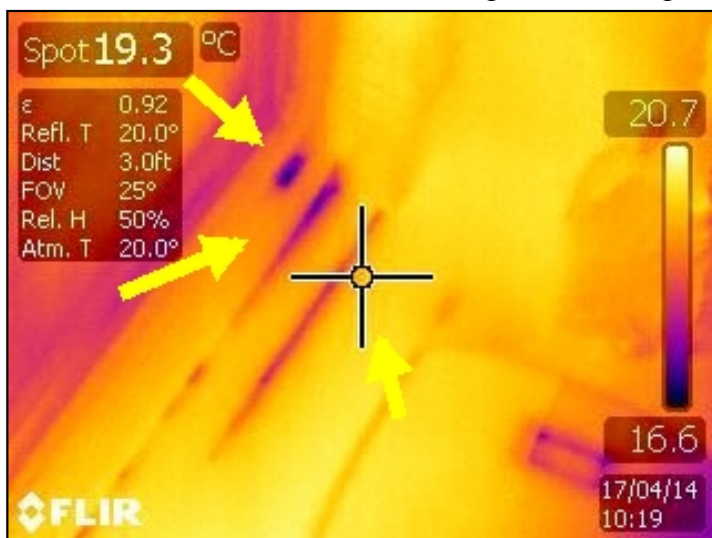
Bedroom 2 en suite - slight leak at shower

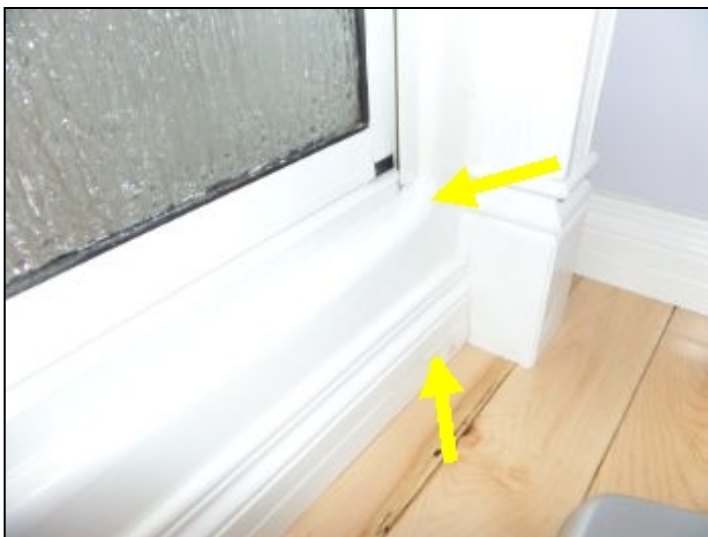
Slight leaking at shower in en suite 2

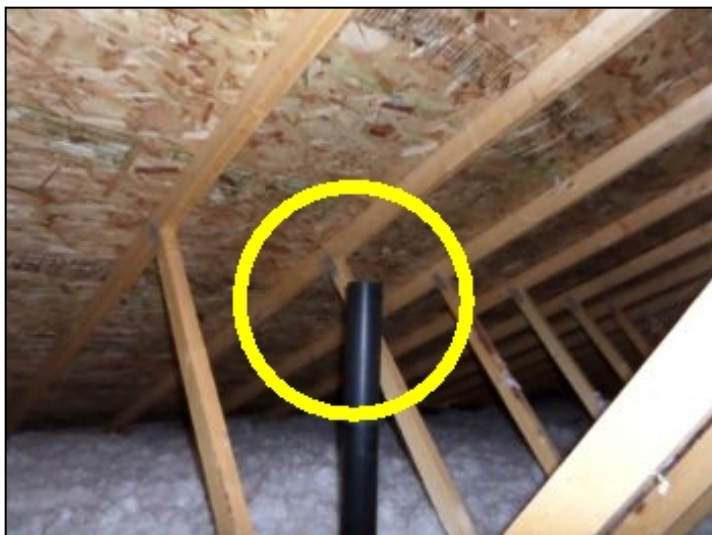
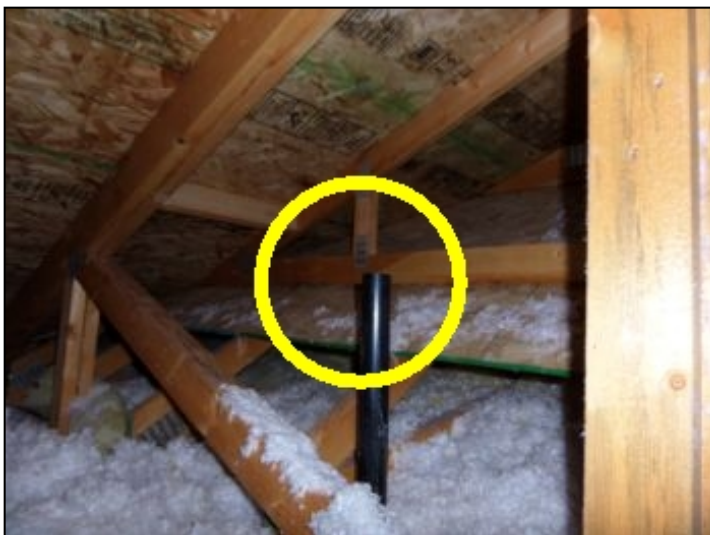
- No leaks at traps, drains or supply lines on day of inspection.
- Bathroom venting into attic - must vent externally

Drain venting should be externally vented

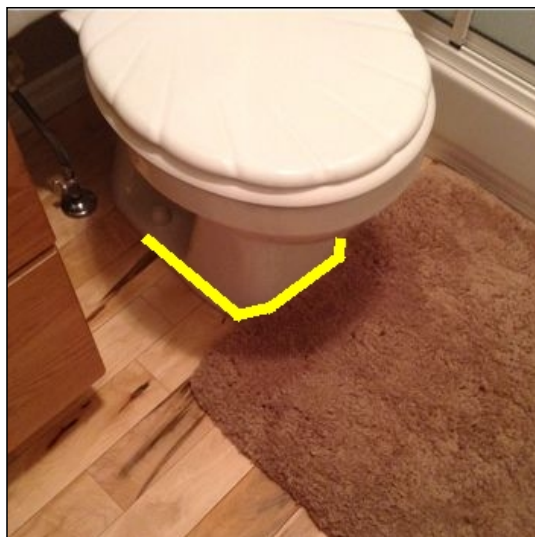
- Some floor covering prevent us seeing hidden damage to sub floors, due to this they are excluded from the responsibility of the inspector.
- The toilet bowl is loose at floor anchor bolts. The wax ring inside the unit must have a snug, secure fit in order to keep from leaking. Properly resealing and re-securing this unit is suggested to prevent water leakage and damage to the sub-floor area.
- Suggest tightening the anchor bolts and caulking part way around the base to stop excess movement, once caulked do not use for 24 hours.
- **Toilet slightly loose. Recommend tightening to prevent water damage.**

Partly caulk toilet in en suite to secure

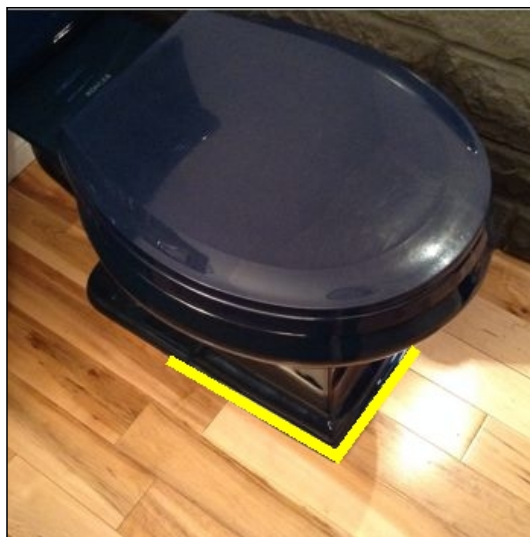
Secure master en suite toilet

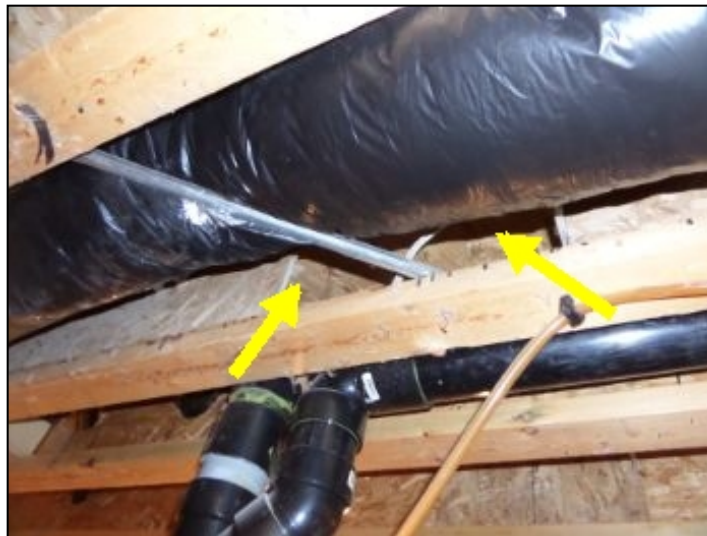
- Floor joists are an important part of the supportive structure of a floor. They hold up the weight of a building, absorb impacts on the floor, and create structural support so that the floor will be stable and secure. Suggest consulting professional prior to modification.

Over cutting weakens the floor joists

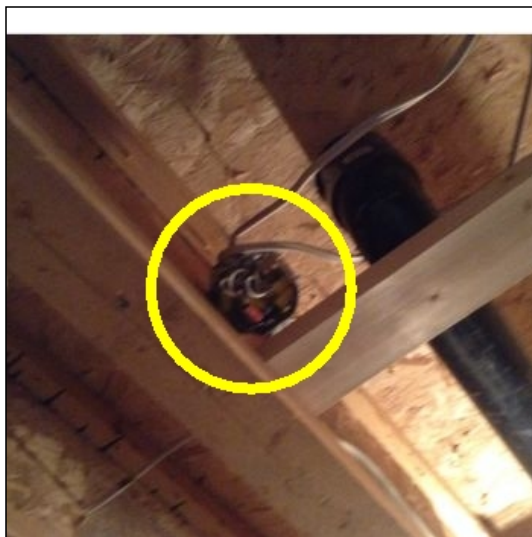
Seal open junction box in furnace room

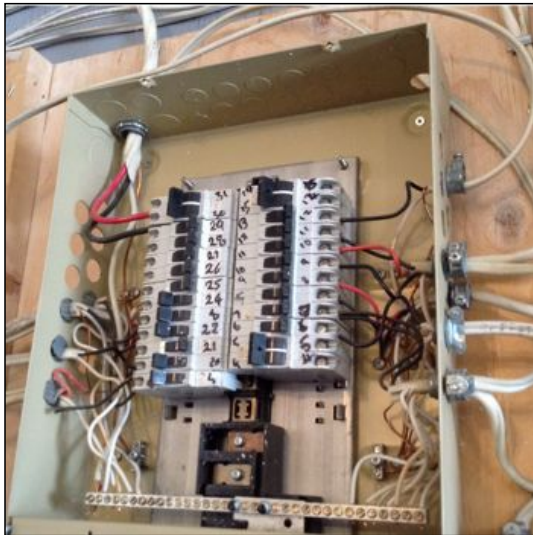
- Located in garage
- Double tapping observed at one position. Double tapping (i.e. 2 wires on a single pole breaker) can add to the load of the affected circuit causing a possible overload and tripping breakers, or result in loose connections and overheating of the breaker or connections. Ideally, doubled-up circuits should be independently fused.

Cover requires attaching to main panel

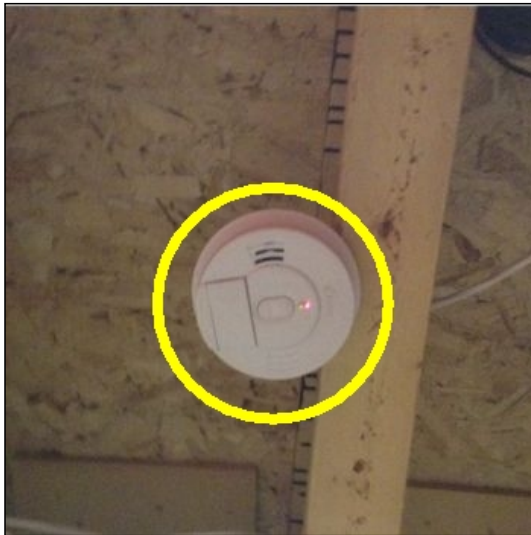
- Periodic testing is suggested to ensure proper working order, these only have a life span of 10 years even if they sound on testing, if age is unable to determine, i suggest replacing all on day of possession.
- Carbon monoxide detectors in place and worked on testing, (CO2 detectors only have a 7 year life span, if age unknown suggest replacing)

All tested and worked as required - due to age replace all and add carbon monoxide detectors

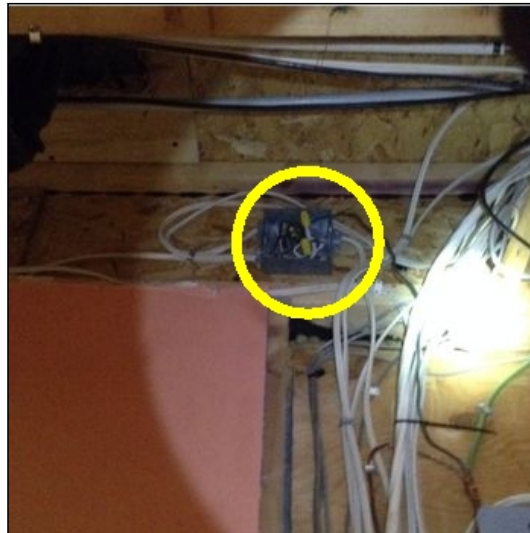
- All electrical issues within the home should repaired/replaced buy a professional electrician, do not attempt repairs unless fully qualified.
- **Open junction boxes were observed, which is a safety concern. Recommend installing proper covers, as needed, for safety.**

Open junction box above main panel

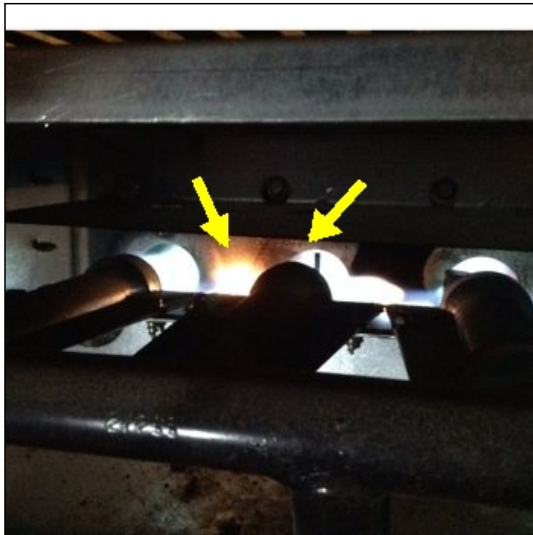
- No record of recent service observed, suggest full clean and service on possession then every 2 years.
- Due to presence of rust, scale, and some debris in this appliance, a service review by a licensed HVAC contractor is advised to ensure proper and safe operation of this unit. Inspection for holes and/or cracks in heat exchangers is not within the scope of this inspection and should be performed prior to closing to ensure the proper and safe operation of the system.

- The presence of soot, carbon, or yellow flame indicates improper combustion may be occurring with this appliance. This is a "Safety Concern". Further review by the local utility company or licensed heating contractor is recommended prior to closing to ensure safety.

Full clean and service required - heating engineer to assess flame issue

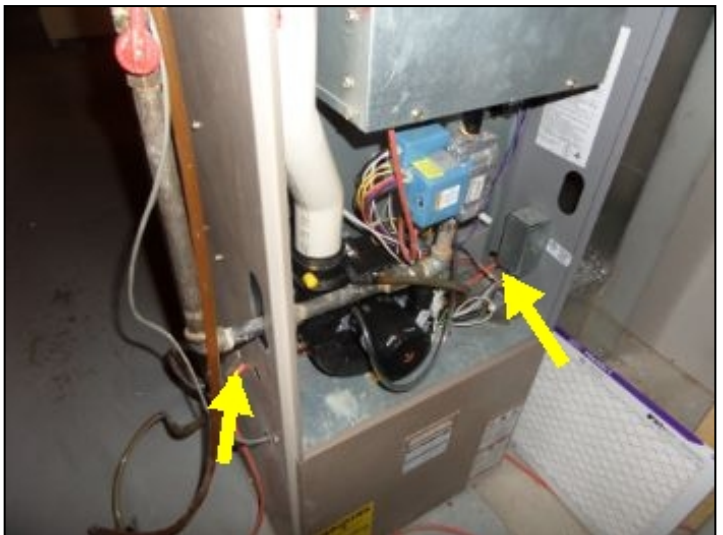
Flame not even - possibly problem - hvac engineer to inspect

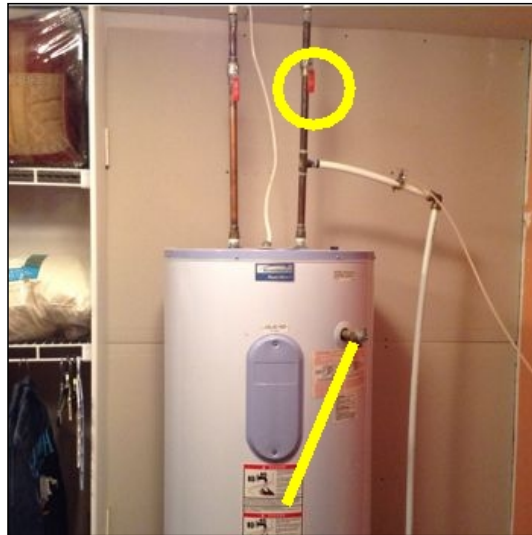
- Serviceable at time of inspection. No warranties can be offered on this or any other appliance.
- Children should be kept away from water heater as the high pressure release valve, if disturbed, can cause scalding.

Water shut off to tank - add pressure relief valve

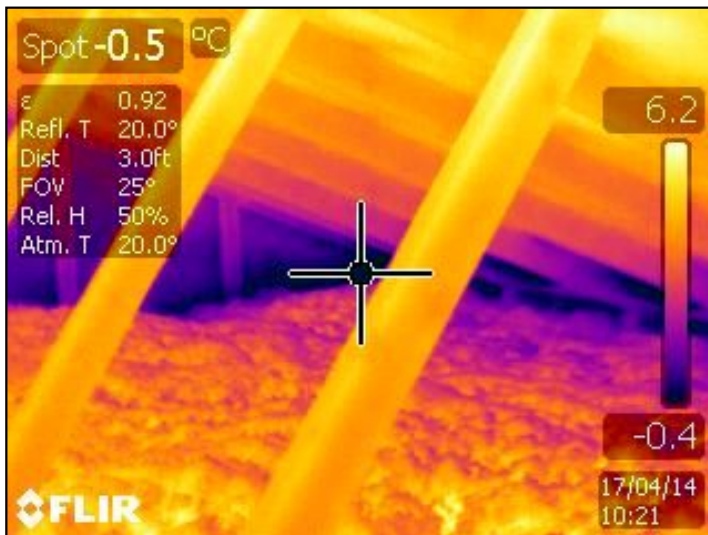
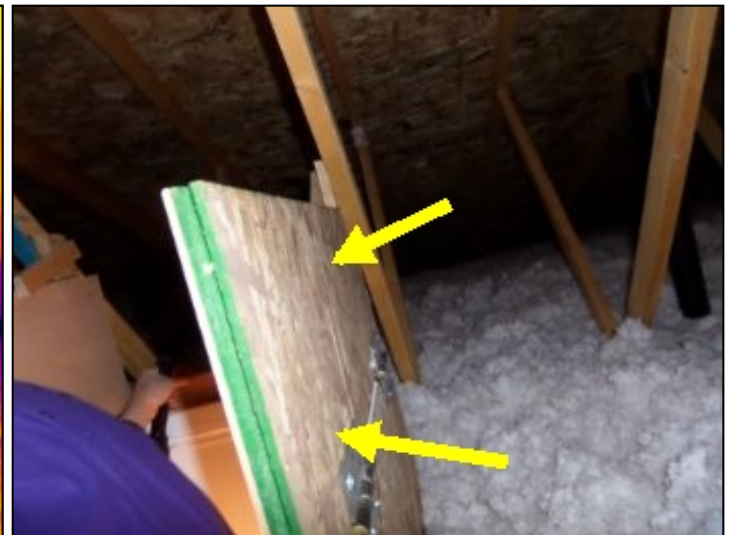
- Approx 12-14 Inches of insulation noted in attic space.
- Suggest adding insulation to the back of the attic hatch, to reduce heat loss.

Add insulation to attic hatch

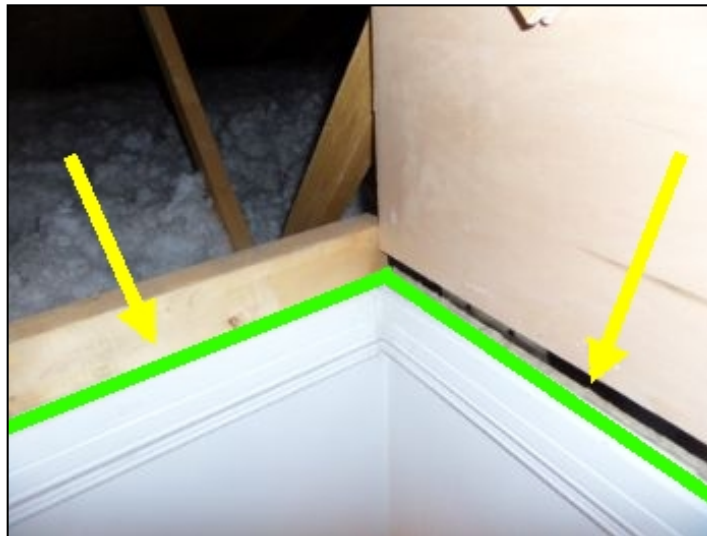
- **Recommend installation of fresh weatherstripping annually at attic hatch to reduce build up of warm moist air.**

Add weatherstripping at attic hatch
