YOUR INSPECTION REPORT

123 Sample Drive S.E.
Calgary, AB

Tuesday, July 24, 2012

RE: Report No. 1004, v.4
123 Sample Drive S.E.
Calgary, AB

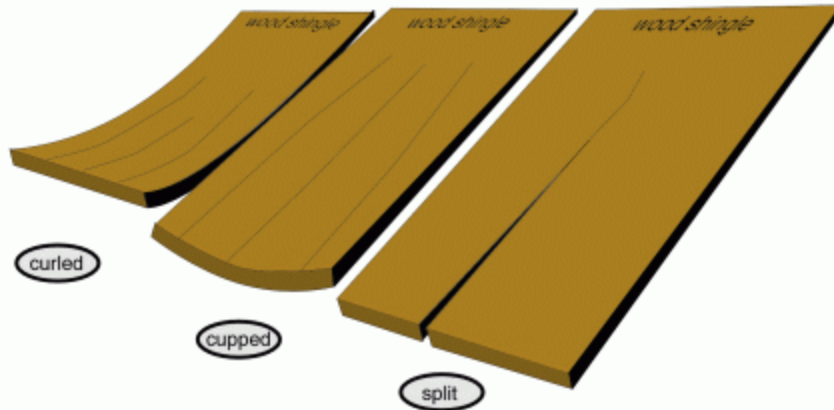
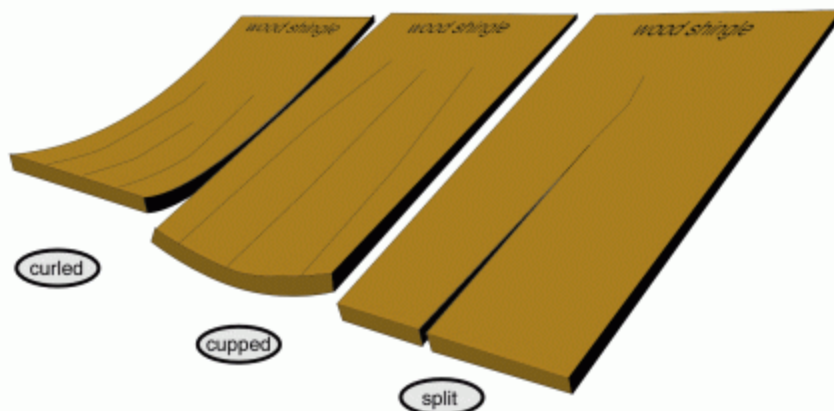
Curling, cupping and splitting wood shingles

Condition: • [Near end of life expectancy](#)

Condition: • [Cupping, curling](#)

Would recommend contacting a roofing company to address this concern.

Task: Replace

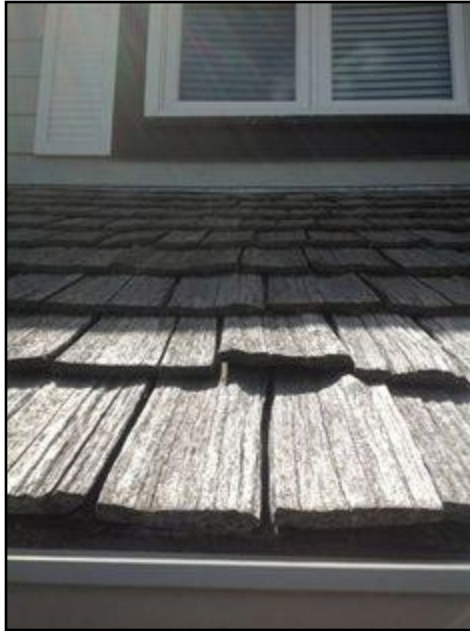
2. Cupping, curling

Implication(s): Chance of water damage to contents, finishes and/or structure

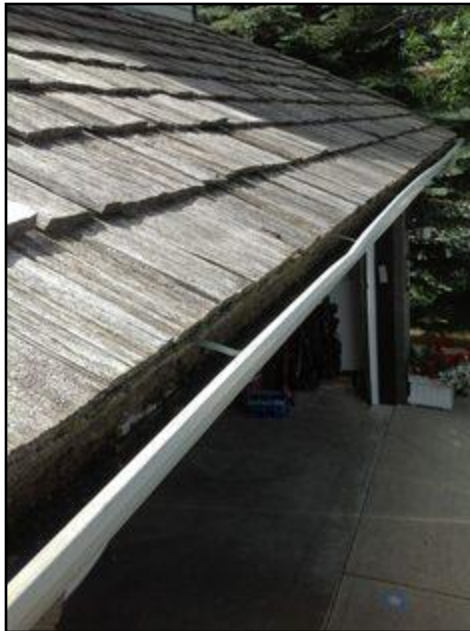
3. Moss, mildew, etc.

Condition: • [Moss, mildew, etc.](#)

Implication(s): Chance of water damage to contents, finishes and/or structure

Task: Repair

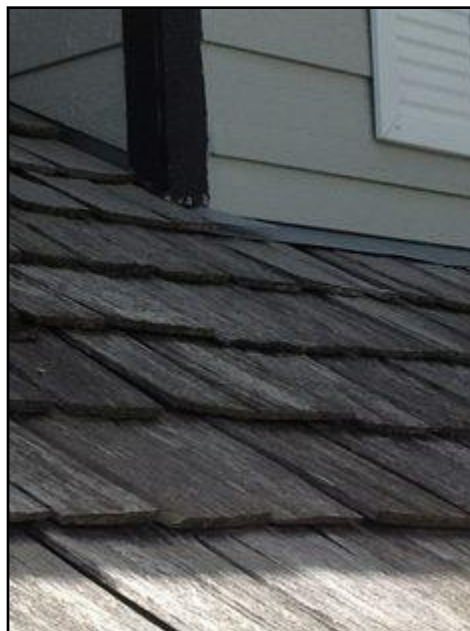
4. Damage, loose, open seams, patched

Condition: • [Damage, loose, open seams, patched](#)

Implication(s): Chance of water damage to contents, finishes and/or structure

Task: Repair

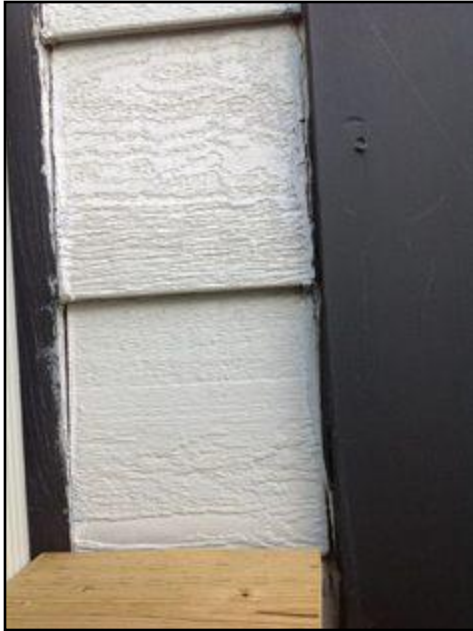
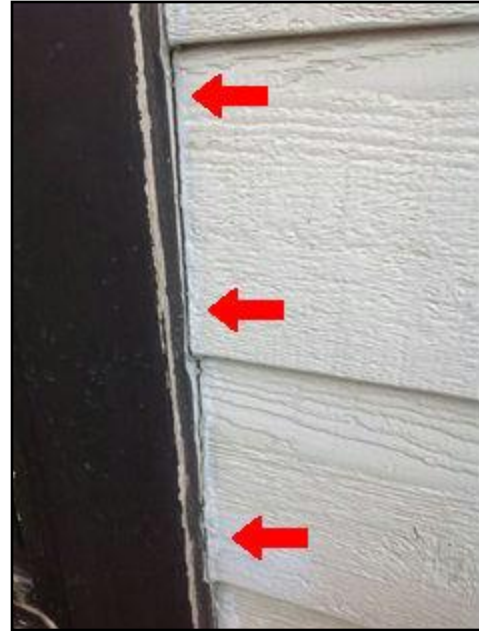
5. Missing paint or caulking

Condition: • Maintaining wood trim - Exterior wood needs regular maintenance to prolong the life expectancy.

Recommend annual inspections and provide paint and caulking when necessary. The wood should be checked for any rot when preparing to paint and the wood should be repaired or replaced if necessary

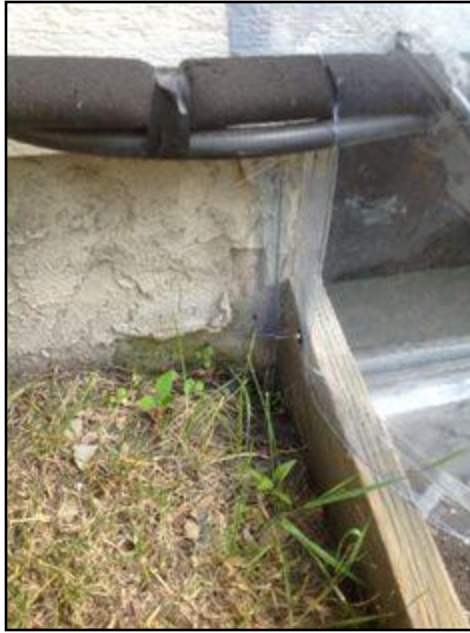
7. Parging damaged or missing

Condition: • [Parging damaged or missing](#)

Cement parging is flaking/deteriorated, this is extremely common and decorative but suggest review for repair as necessary to protect the foundation wall from premature aging.

Implication(s): Chance of damage to structure | Shortened life expectancy of material

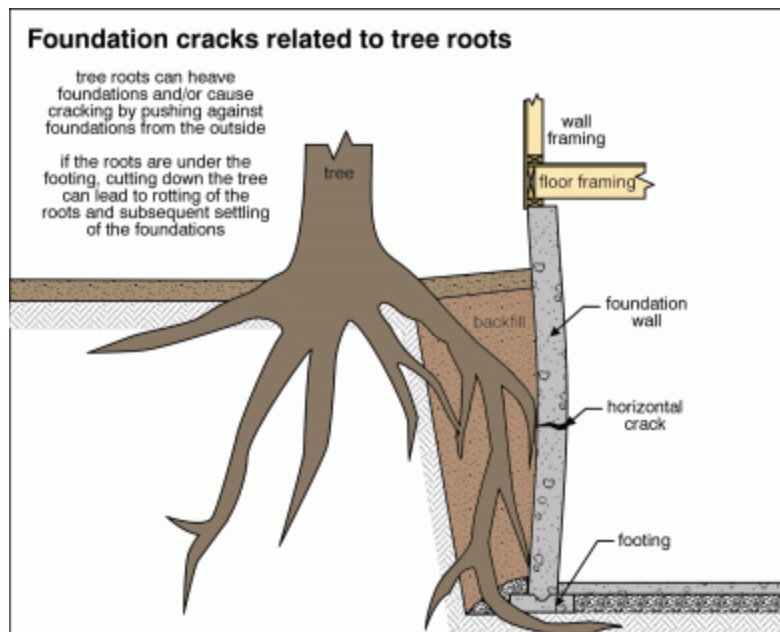
Condition: • [Large trees close to building](#)

Task: Monitor

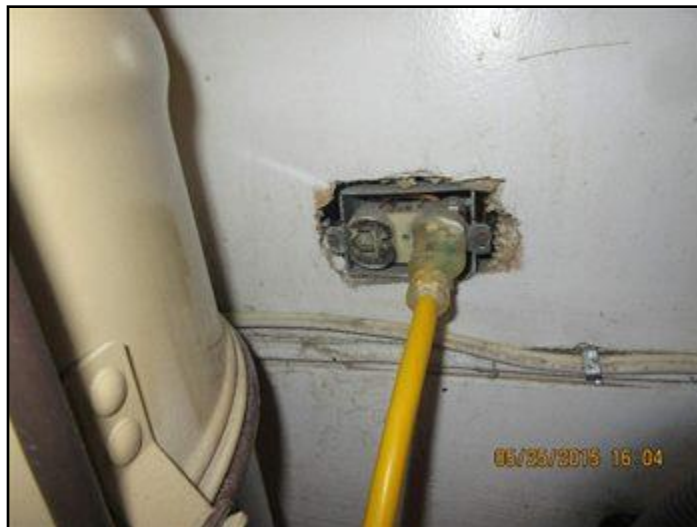
8. Missing

Condition: • [Missing](#)

Implication(s): Electric shock

These cover plates should be replaced as soon as possible, as this is a safety issue.

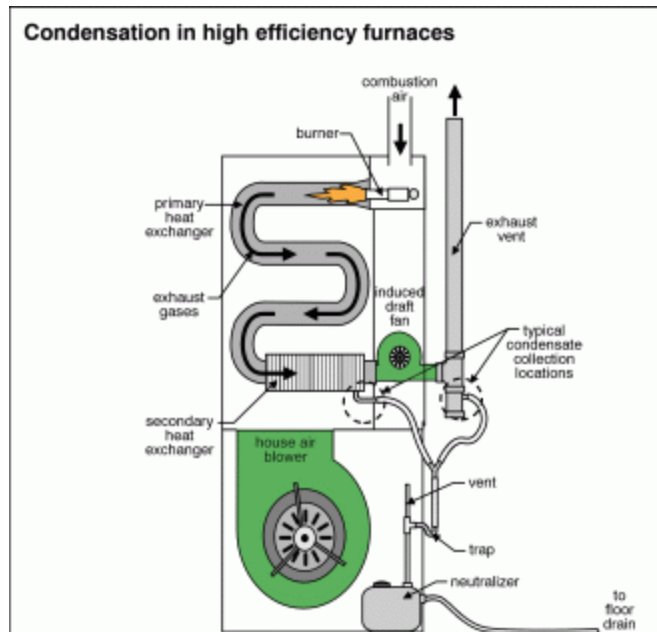
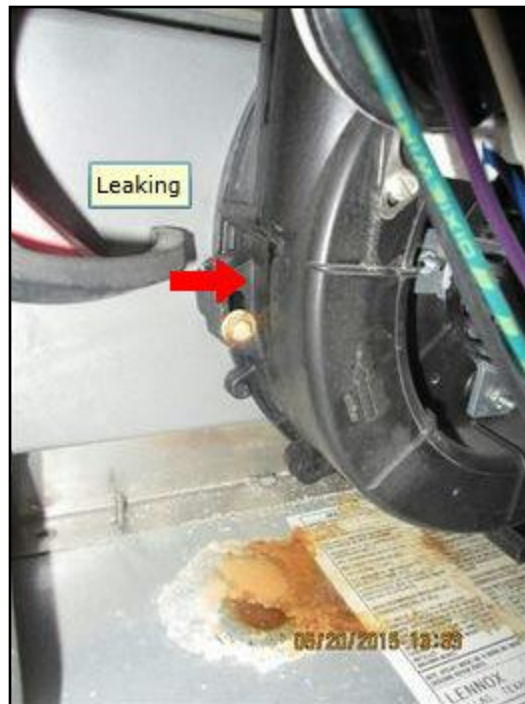
10. Condensate problems

Condition: • [Condensate problems](#)

There was a past leak observed from the inducer fan casing at the time of the inspection. Would recommend having this serviced by a qualified HVAC company as soon as possible. Please open link to view a video of the leak.

Implication(s): Chance of water damage to contents, finishes and/or structure | Reduced system life expectancy

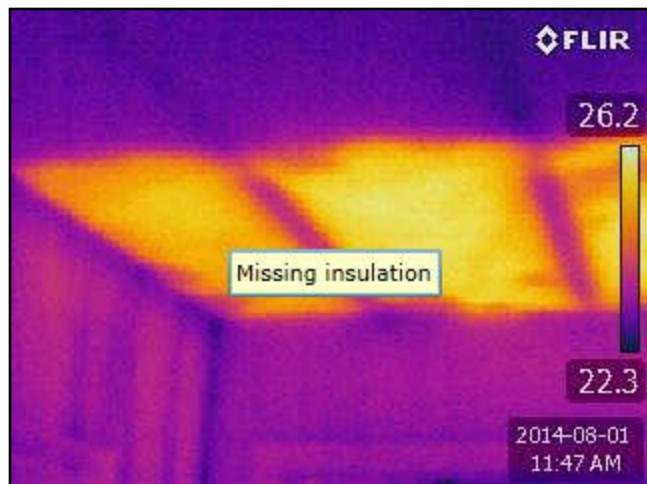
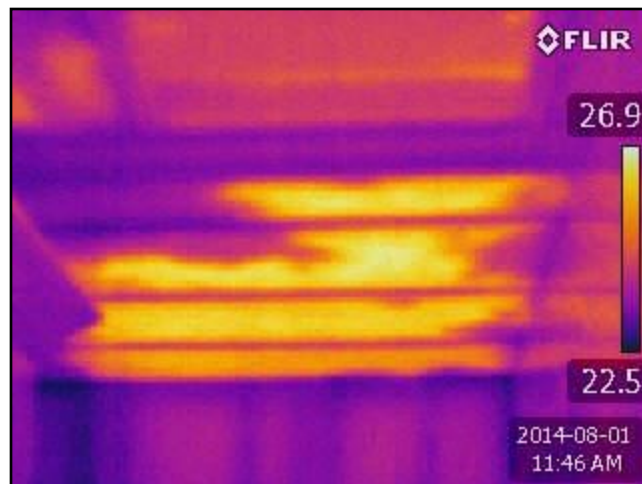
11. Gaps or voids

Condition: • [Gaps or voids](#)

Task: Correct/Improve

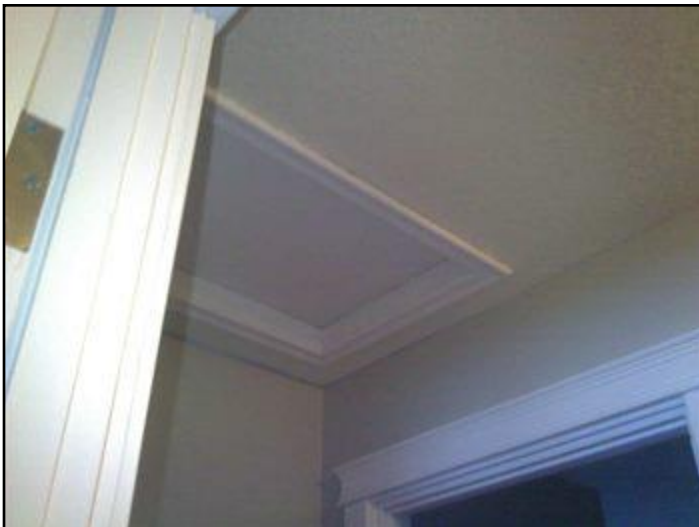
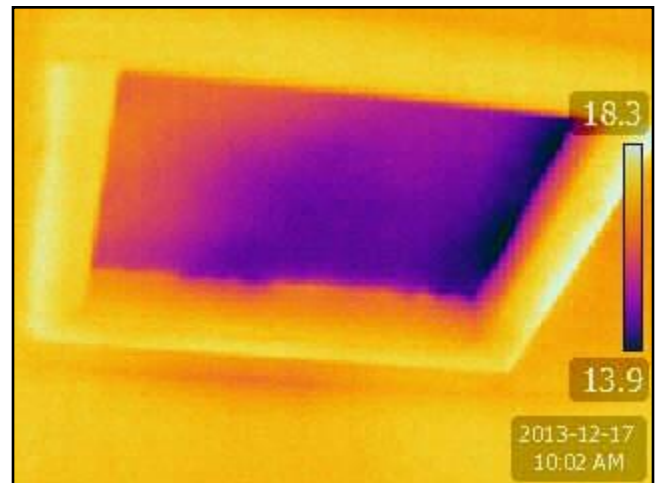
13. Not insulated

Condition: • [Not insulated](#)

Missing Insulation

An attic access that is not insulated is a big hole and deficiency in the thermal barrier between the attic and the condition space. This gap in the attic insulation increases heat loss in the winter and heat gain in the summer.

An unsealed attic access can potentially leak the same amount of air supplied by a typical bedroom-heating duct (100 CFM). To insulate an attic

access, a lightweight, move able box or panel can be constructed from rigid foam to fit over the access from the attic side. Would recommend having the builder correct this issue as soon as possible.

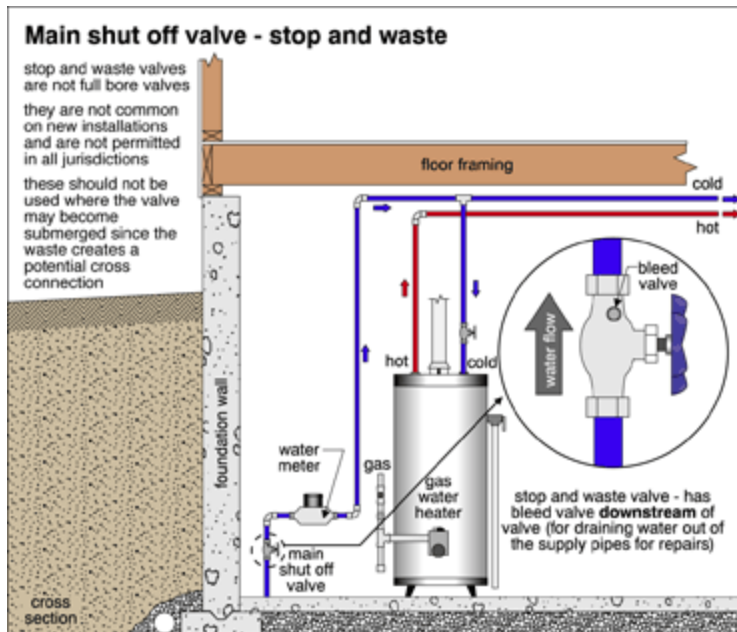
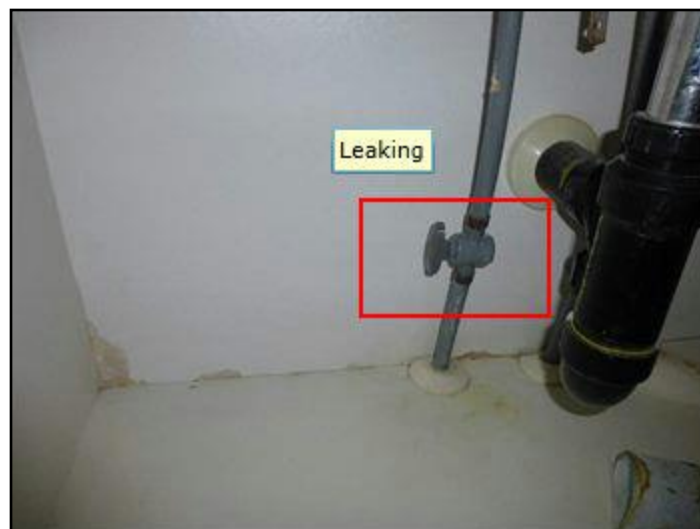
15. Leak

Condition: • [Leak](#)
The main shut off for the bathroom sink was leaking at the time of the inspection. Would contact a qualified plumber to address this issue.

Implication(s): Chance of water damage to contents, finishes and/or structure | No water

Task: Repair A qualified plumbing company should be contacted for this item

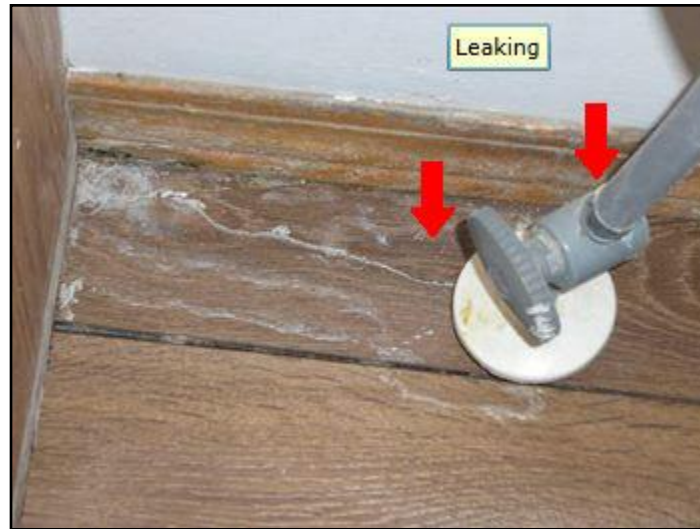
16. Leakage at the toilet water supply...

Condition: • Leakage at the toilet water supply connection was observed at the time of the inspection. The Inspector

recommends supply pipe replacement by a qualified plumbing contractor to avoid future damage from leakage or failure.

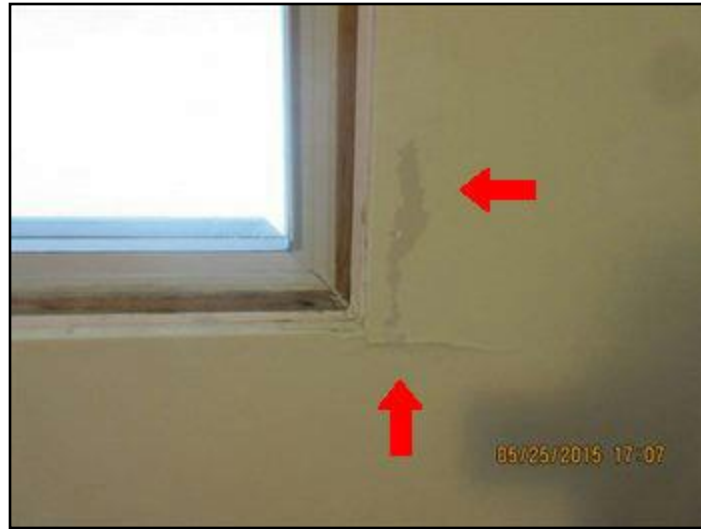
17. Damaged

Condition: • Damaged

Implication(s): Cosmetic defects

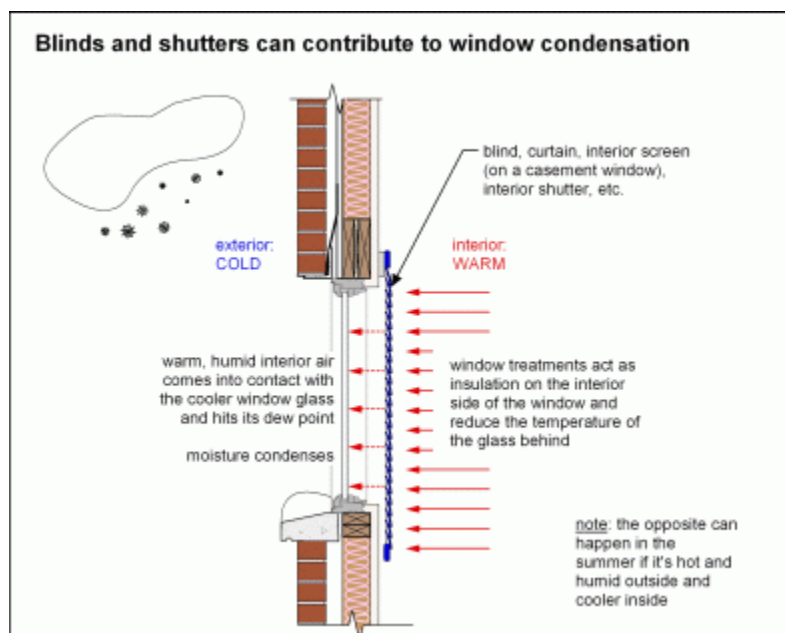
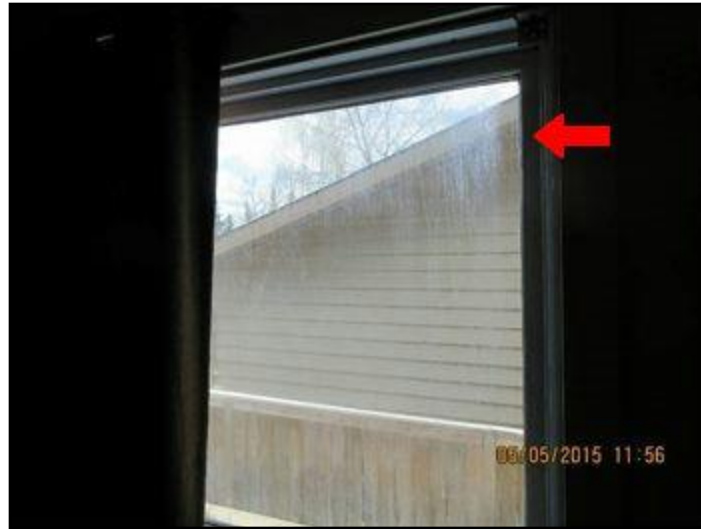
18. *Excess condensation*

Condition: • [Excess condensation](#)

Many of the window sills had water staining from what appeared to be from condensation. This is a result of high humidity and should always be monitored. These problems may impact window performance, leakage of water and air and operation problems are likely results.

Implication(s): Chance of condensation damage to finishes and/or structure

Task: Repair

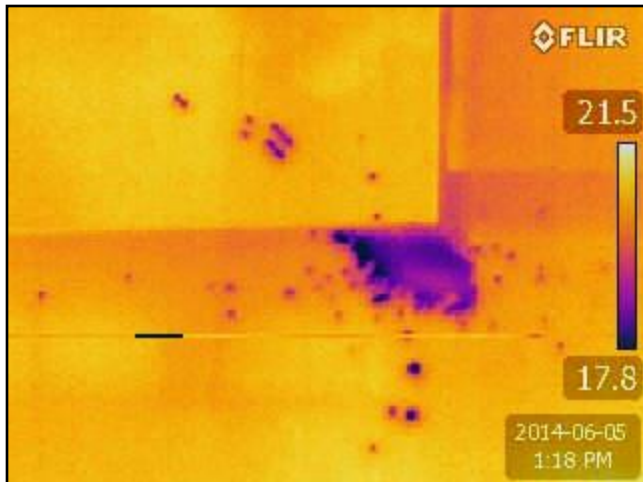
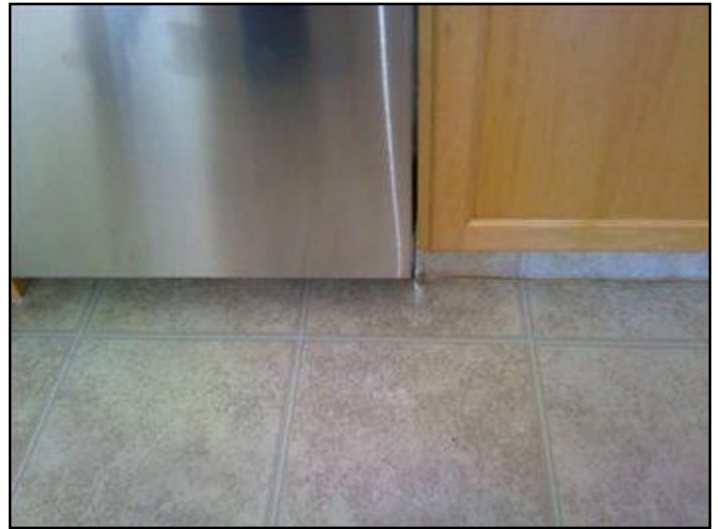
19. Unit is leaking

Condition: • Unit is leaking

Would contact a qualified appliance repair company to fix this as soon as possible.
