Inspection Report

2222 - Rocky Mountain St SW
Calgary Ab

Mr. Home Inspection Services Inc.

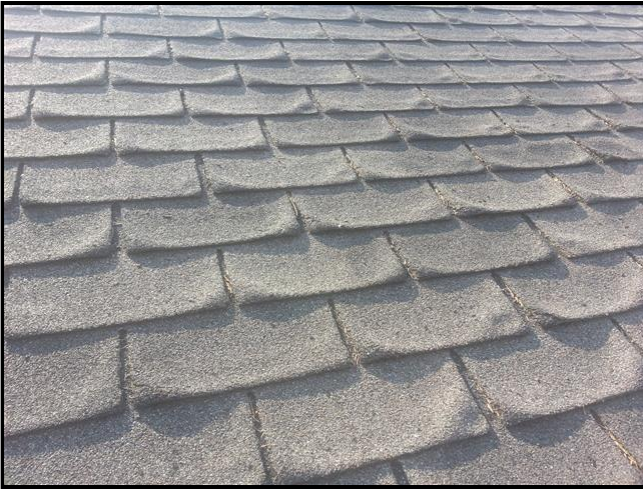
1.0 Item 1(Picture)

The roof covering has some visual damage to the roof covering from age and weather. this area has been hard hit in recent years with bad weather reducing the service life of the shingles. I recommend a qualified roofing contractor inspect the roof.

The roof covering has visual damage to the roof covering, Some areas may need patching with tar if leaks develop. I recommend a qualified roofing contractor inspect the roof.

You should plan on replacement

1.0 I recommend an annual roofing tune up by a qualified roofing contractor to maintain the roofing cover.

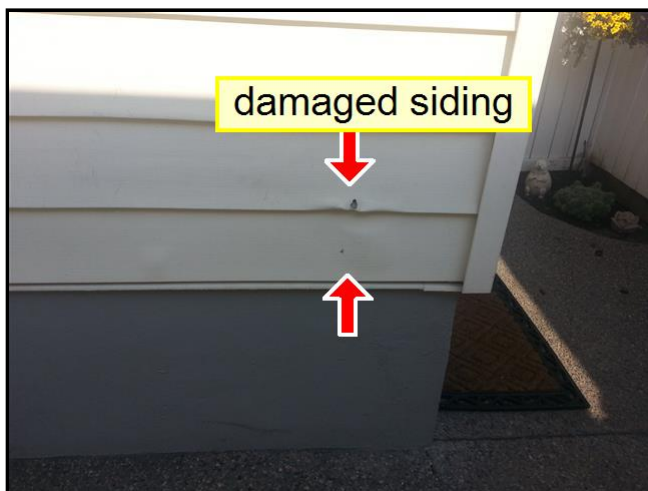
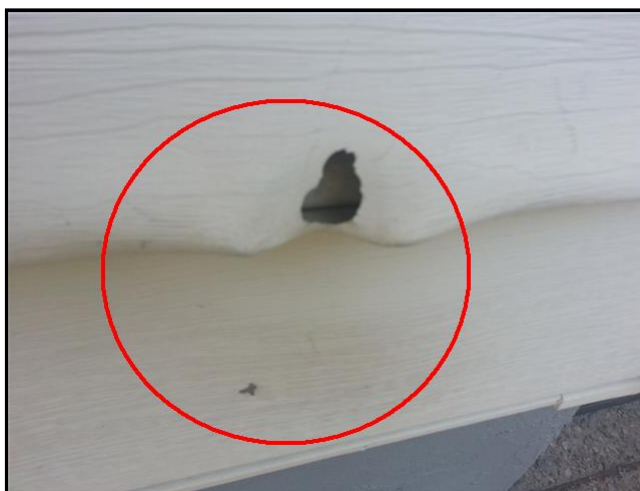
2.0 Item 1(Picture)

2.0 The siding is damaged at rear as shown

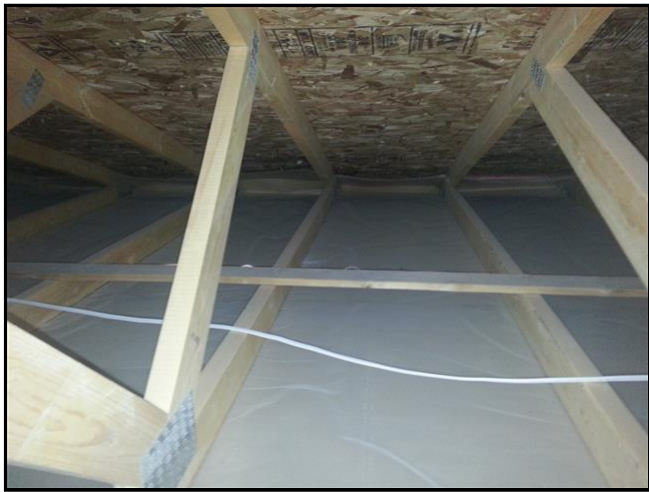
3.1 Item 2(Picture)

3.1 The garage attic is not insulated

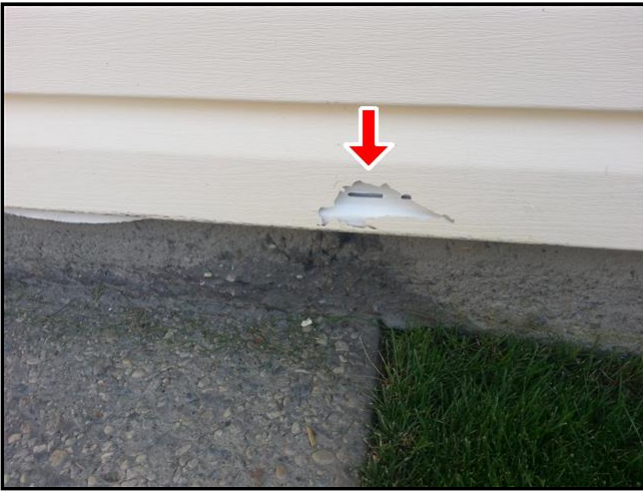
3.6 Item 1(Picture)

3.6 siding damaged as shown

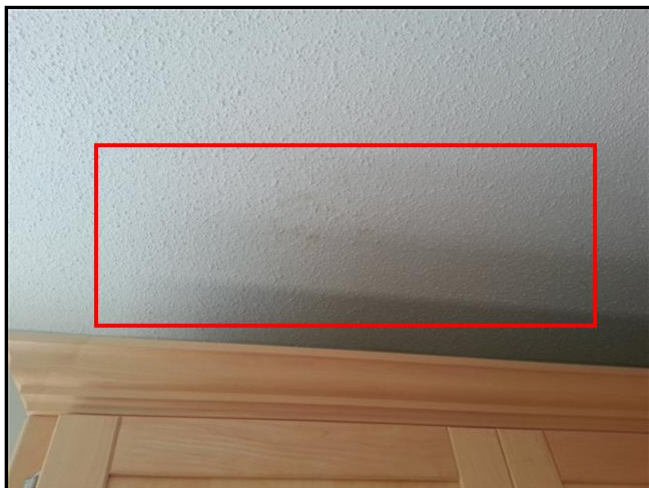
4.0 Item 1(Picture)

4.0 (1) There is a old moisture stain in kitchen on ceiling as shown, it was dry today, it may have been caused by an un-insulated and detached duct in the attic.

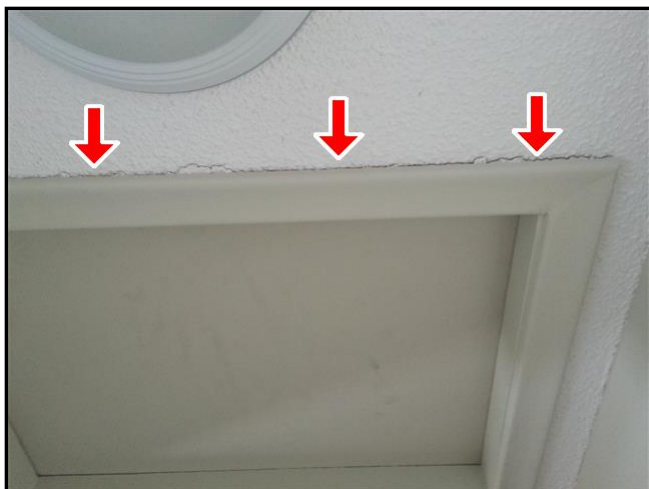
4.0 Item 3(Picture)

(2) damage around ceiling hatch was existing before inspection

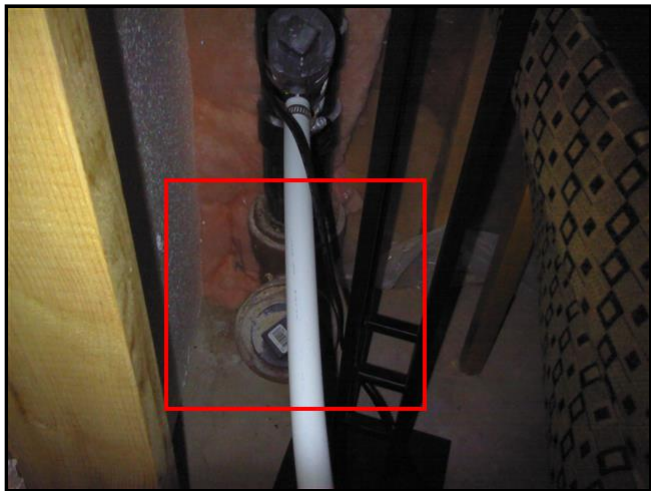
6.0 Item 7(Picture)

(3) cast iron to ABS in store room, main clean out is here

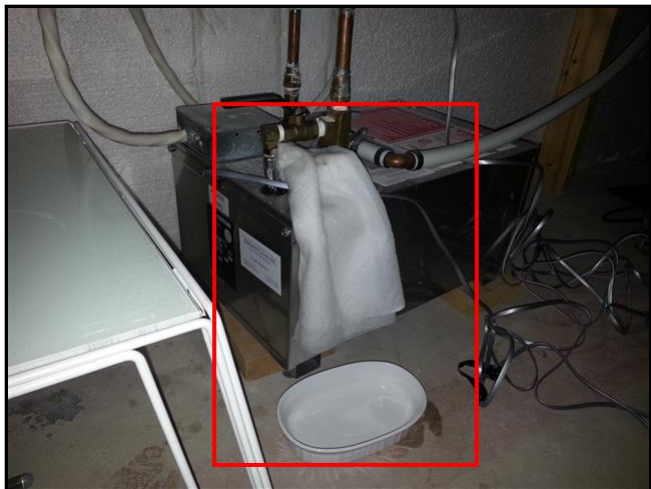
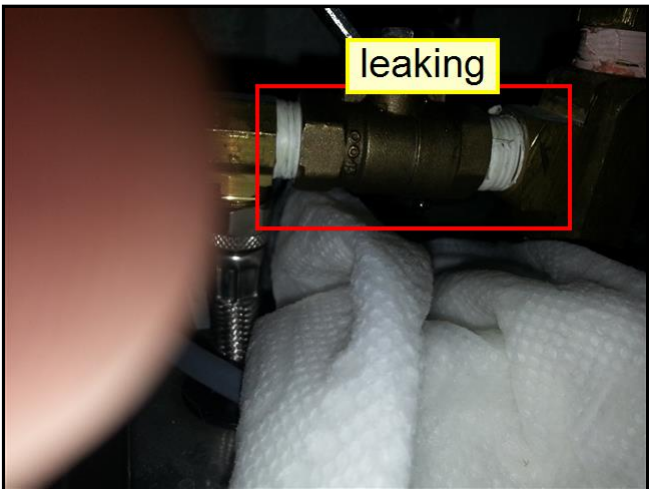
6.1 Item 1(Picture)

6.1 The steam shower unit is located in the basement store room below the master bathroom, the unit is leaking at the water connection and requires repairs.

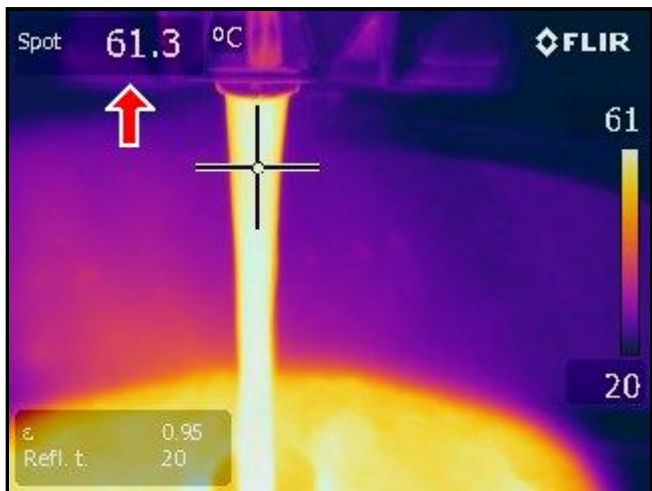
6.2 Item 2(Picture)

(2) hot water checked with FLIR camera, the water temperature is very hot and could injure, you should lower the temperature to a safer temperature to prevent a injury.

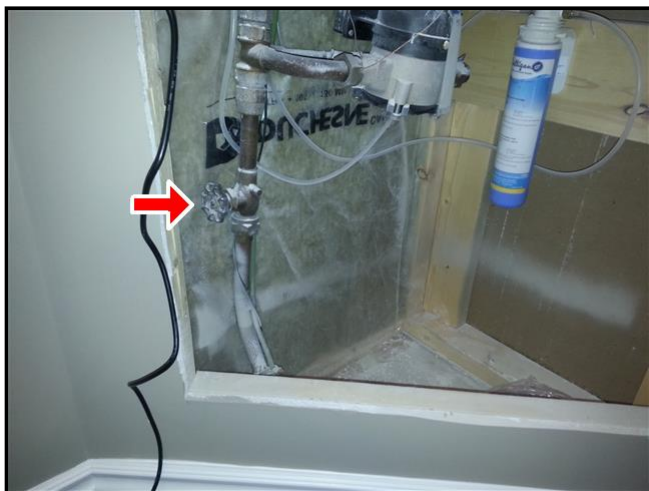
6.3 Item 1(Picture)

6.3 The main water shut off is located in basement as shown

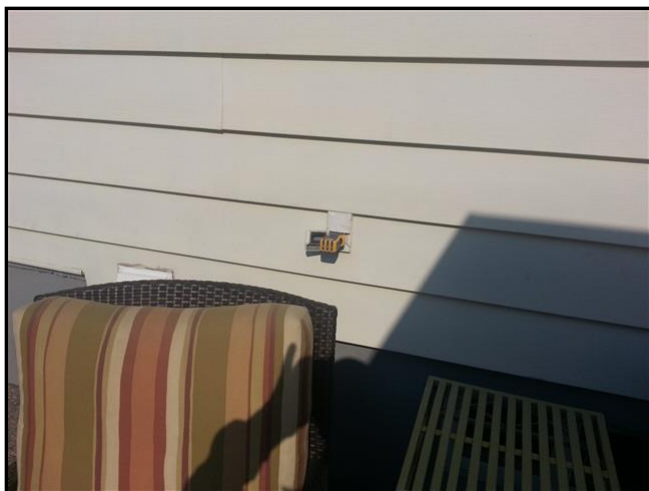
7.3 Item 1(Picture)

7.3 (1) **The exterior outlets on the house are not GFCI equipped, I recommend for safety installing GFCI by a qualified electrical contractor.**

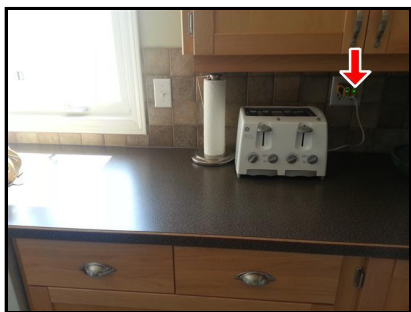
7.3 Item 2(Picture)

(2) The kitchen countertop outlets are not equipped with GFCI, this dwelling was constructed before it was required but I recommend installing GFCI for safety by a qualified electrical contractor.

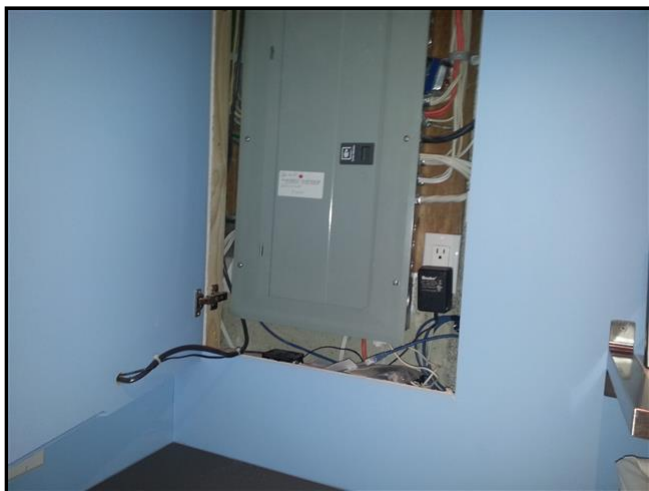
7.5 Item 1(Picture)

7.5 The main panel box is located at the basement.

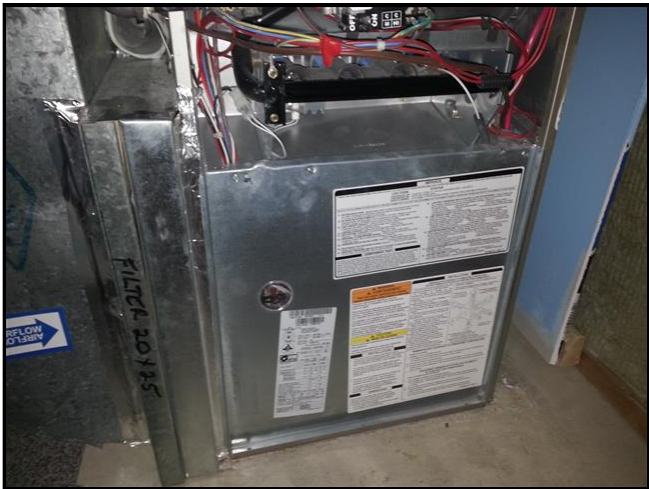
8.0 Item 1(Picture)

The furnace is over 8 years old (2006 Sept) but did work at time of inspection. I am unable to determine life remaining.

8.0 (1) I recommend an annual furnace tune up by a qualified HVAC contractor to ensure safe and effective operation of the heating equipment.

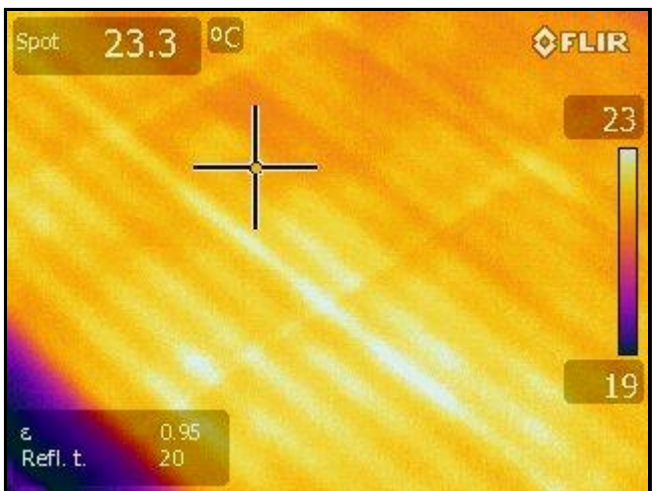
(2) The in floor heating in the 3 bathroom's was checked with FLIR camera, no issues detected today.

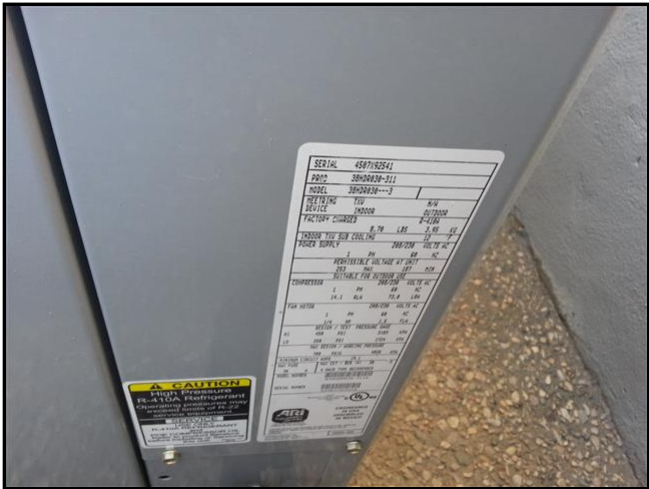
8.6 Item 1(Picture)

8.6 I recommend an annual Air conditioning tune up by a qualified HVAC contractor to ensure safe and effective operation of the cooling equipment. The outside unit should be covered in the winter season, and turn the AC breaker off at the panel. In spring turn breaker on and wait at least 1 hour for warm up before operating.

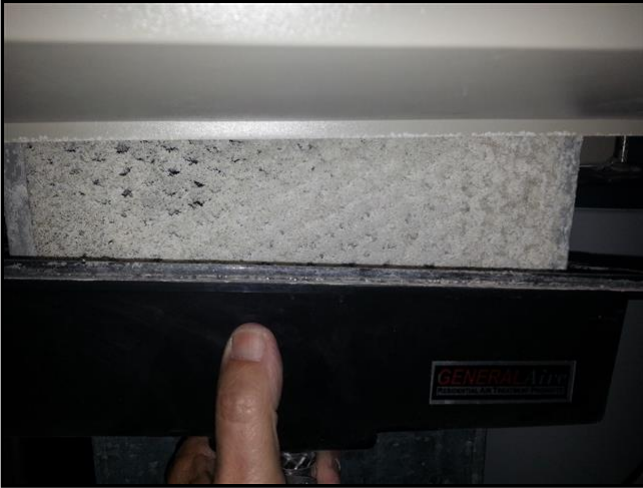
8.9 Item 1(Picture)

8.9 The humidifier filter needs to be replaced now as it is clogged, it also should be cleaned/ replaced annually

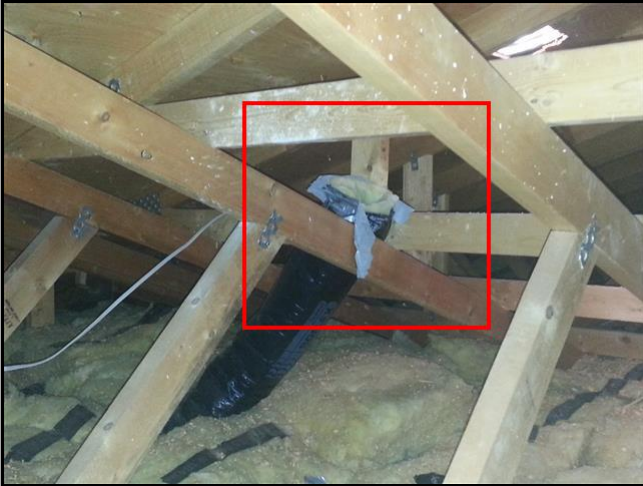
9.4 Item 1(Picture)

9.4 (1) The main and master bathroom exhaust ducts are disconnected in attic, repairs are required to reattach to prevent moisture issues.

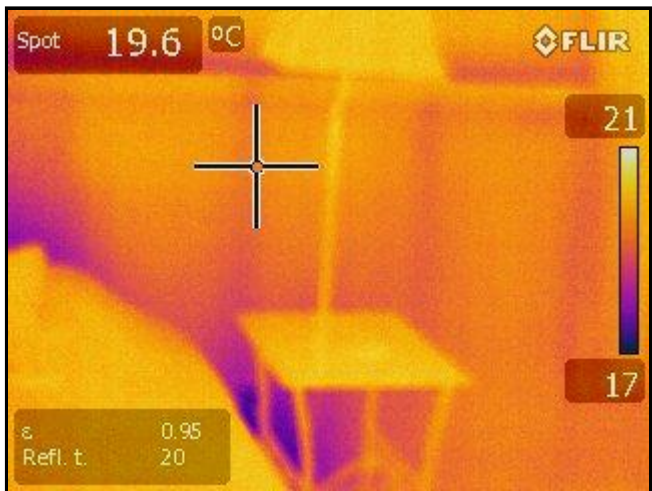
9.6 inspected with FLIR camera

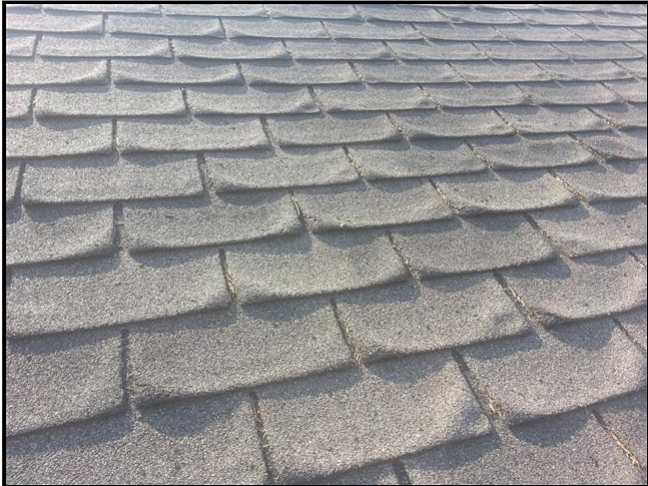
1.0 Item 1(Picture)

The roof covering has some visual damage to the roof covering from age and weather. this area has been hard hit in recent years with bad weather reducing the service life of the shingles. I recommend a qualified roofing contractor inspect the roof.

The roof covering has visual damage to the roof covering. Some areas may need patching with tar if leaks develop. I recommend a qualified roofing contractor inspect the roof.

You should plan on replacement

I recommend an annual roofing tune up by a qualified roofing contractor to maintain the roofing cover.

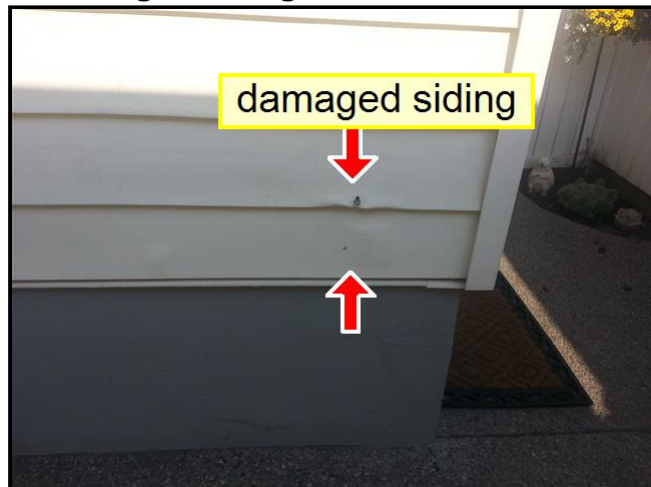
2.0 Item 1(Picture)

The siding is damaged at rear as shown

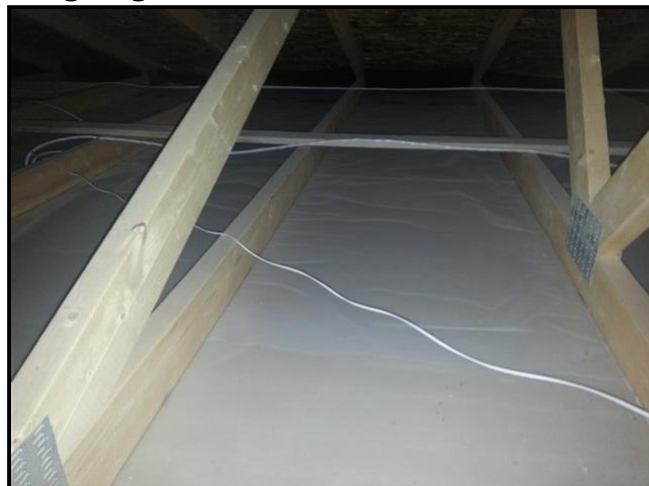
3.1 Item 1(Picture)

The garage attic is not insulated

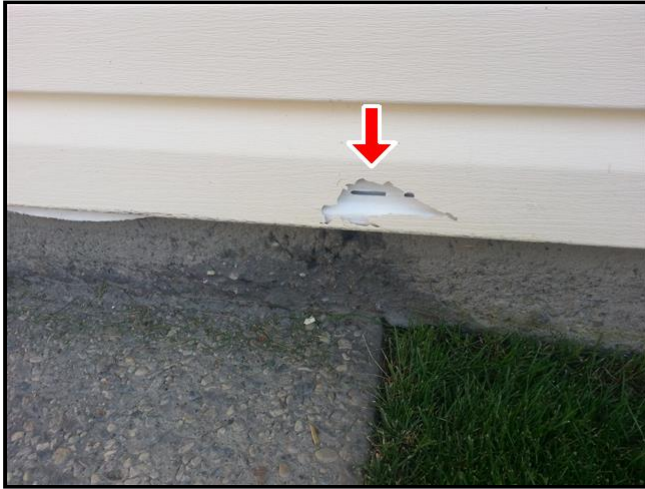
3.6 Item 1(Picture)

siding damaged as shown

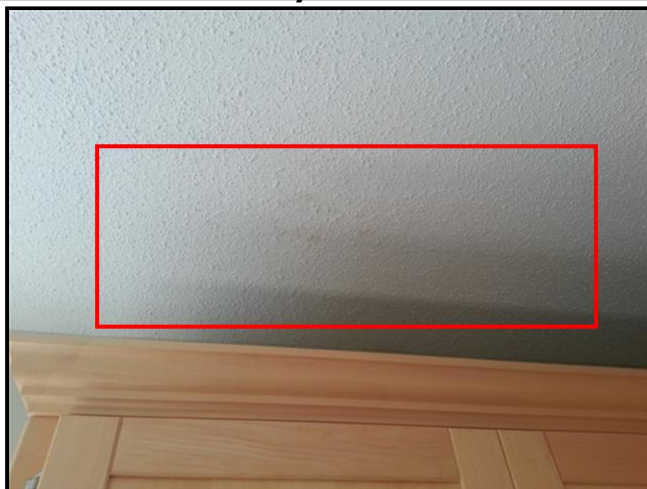
4.0 Item 1(Picture)

(1) **There is a old moisture stain in kitchen on ceiling as shown, it was dry today, it may have been caused by an un-insulated and detached duct in the attic.**

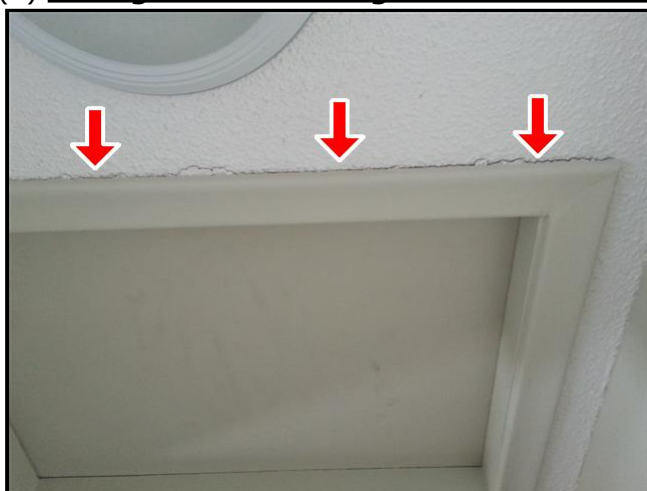
4.0 Item 3(Picture)

(2) **damage around ceiling hatch was existing before inspection**

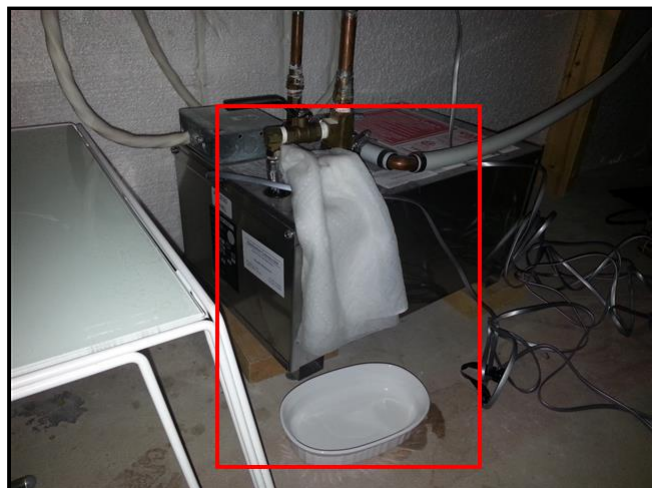
6.1 Item 1(Picture)

The steam shower unit is located in the basement store room below the master bathroom, the unit is leaking at the water connection and requires repairs.

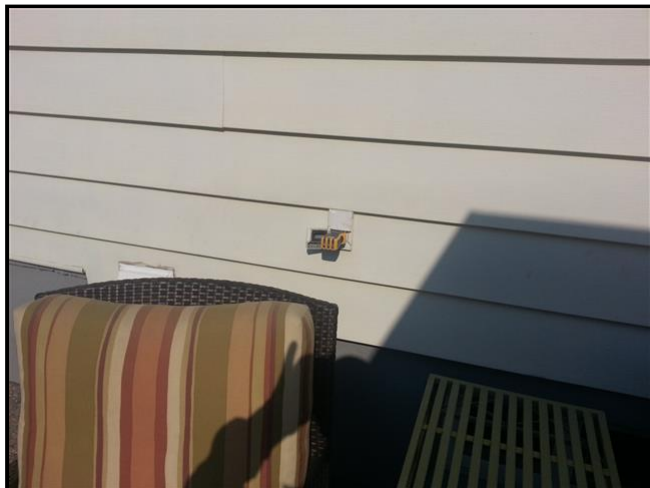
7.3 Item 1(Picture)

(1) The exterior outlets on the house are not GFCI equipped, I recommend for safety installing GFCI by a qualified electrical contractor.

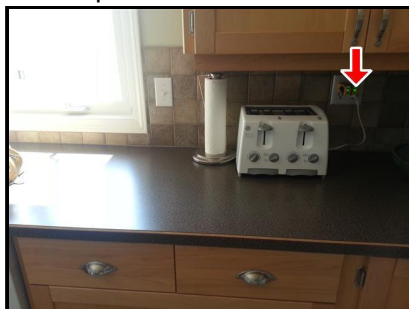
7.3 Item 2(Picture)

(2) The kitchen countertop outlets are not equipped with GFCI, this dwelling was constructed before it was required but I recommend installing GFCI for safety by a qualified electrical contractor.

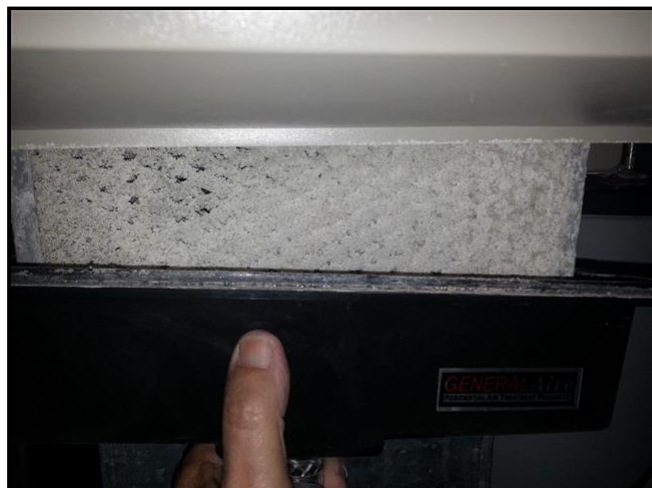
8.9 Item 1(Picture)

The humidifier filter needs to be replaced now as it is clogged, it also should be cleaned/ replaced annually

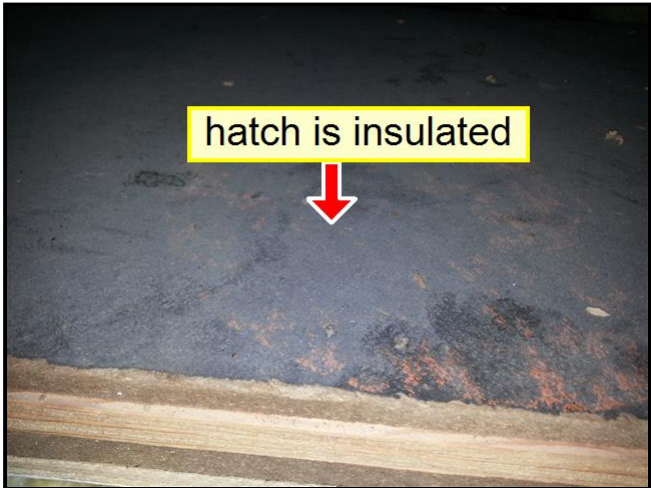
9.0 Item 1(Picture)

(1) The attic hatch is not insulated, I recommend insulating to prevent heat loss.

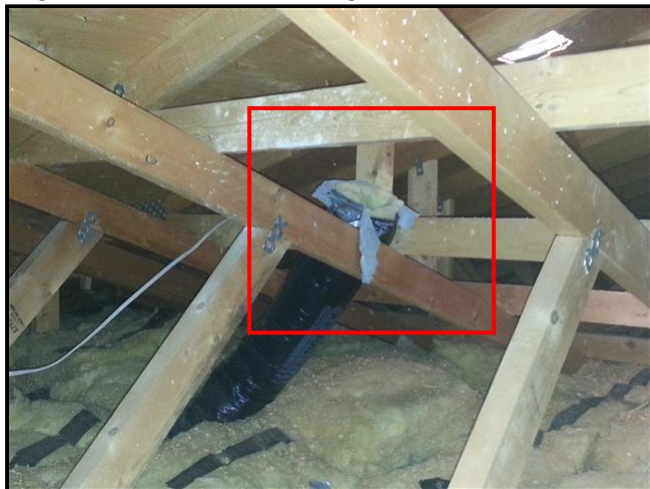
9.4 Item 1(Picture)

(1) **The main and master bathroom exhaust ducts are disconnected in attic, repairs are required to reattach to prevent moisture issues.**

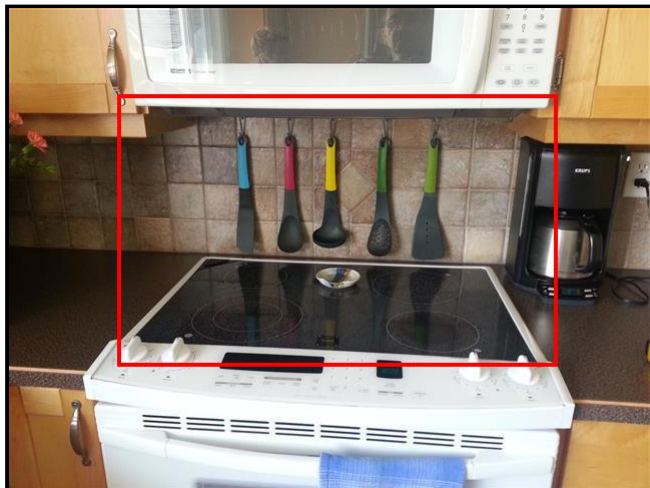
9.4 Item 5(Picture)

(3) **The clearance between the electric cooktop and the exhaust should be 21 inches it is 16 1/2 inches**
