Odds On Home Inspection Services

Home Inspection Report

1234 Mock Street , calgary, Alberta

Date of Inspection: 4/17/2014 Time: 4pm
Age of Home: 2004 Size: Approx 2400 sq ft
Weather: Cool - Cloudy

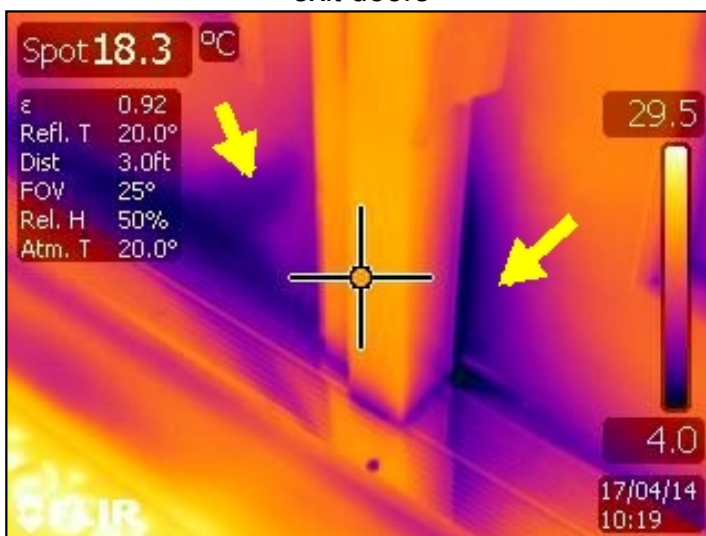
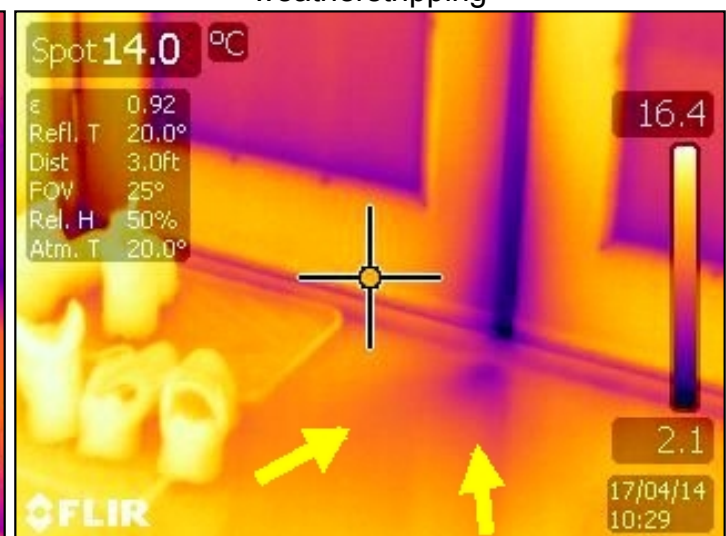
- Highly recommend replacing all weatherstripping and door sweeps, if and when required to reduce heat loss in the home.
- Adjusting lock sets at exit doors will allow the door to pull tighter to the weatherstripping reduce heat loss during the winter months.

Heat loss at exit doors due to poor weatherstripping

Replace weatherstripping to reduce heat loss at exit doors

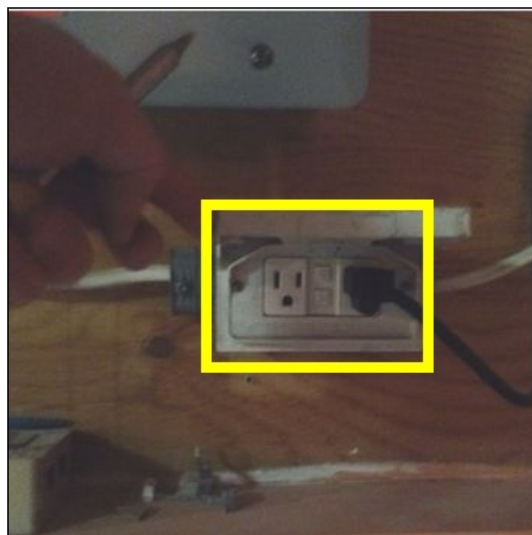
- GFCI in place and operational
- GFCI resets at main electrical panel

Reset for external receptacles - under main panel

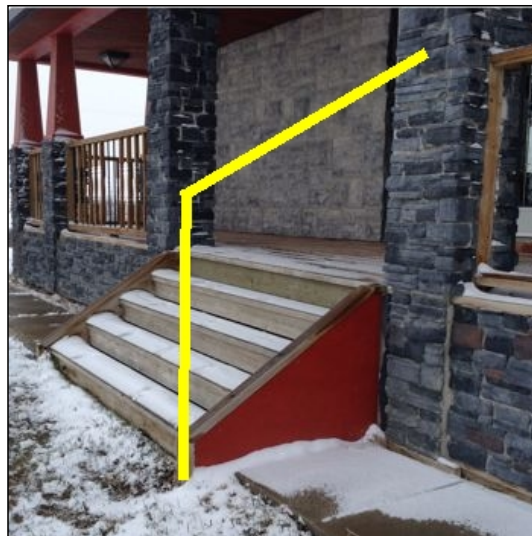
- Stairs in good order but no handrail present - This is a safety feature and should be in place when 3 or more stairs are in place.

Add handrail at steps as required

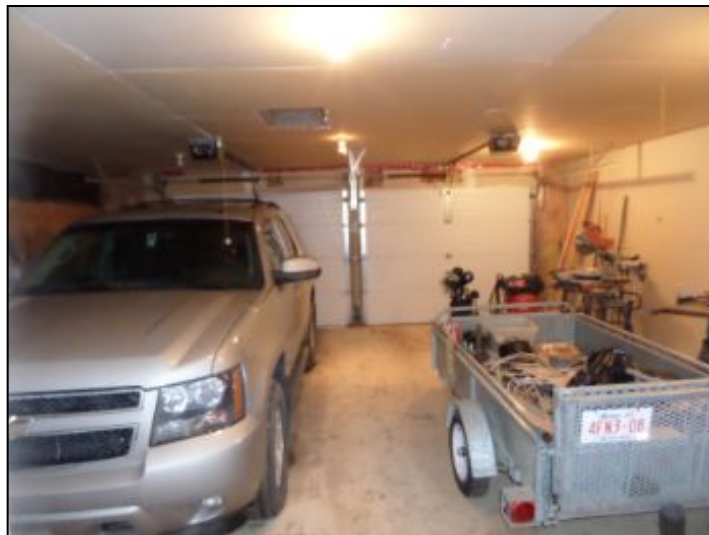
Gargae area

- Common cracks noted - This is common settlement and no reason for concern. Dry at the time of the inspection.

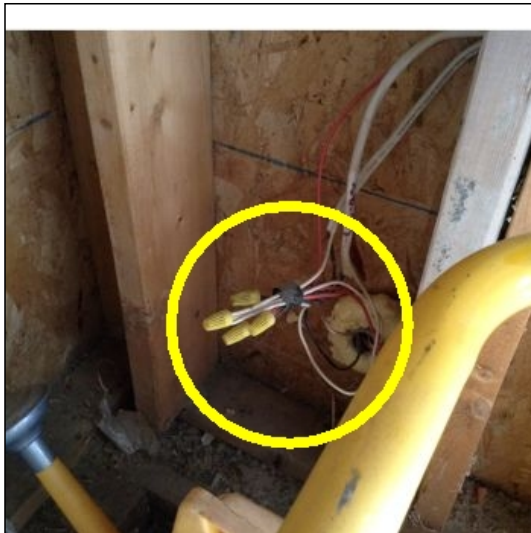
All wires should be in sealed junction boxes

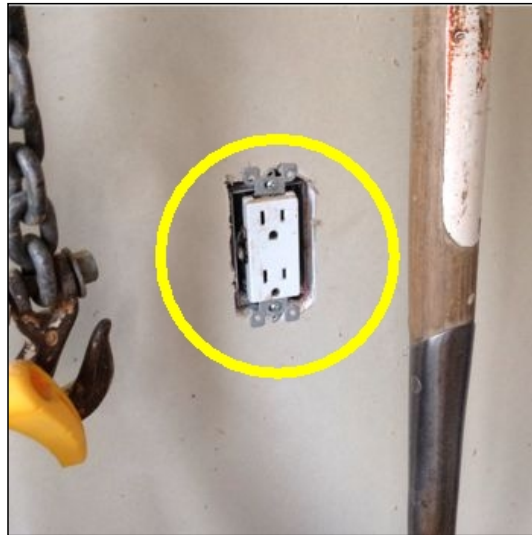
- All assessable electrical outlets were tested for faults - No issues to report.
- Limited review of all receptacles due to personal storage.
- Add cover plates to receptacles and light switches for safety.

Add cover plates

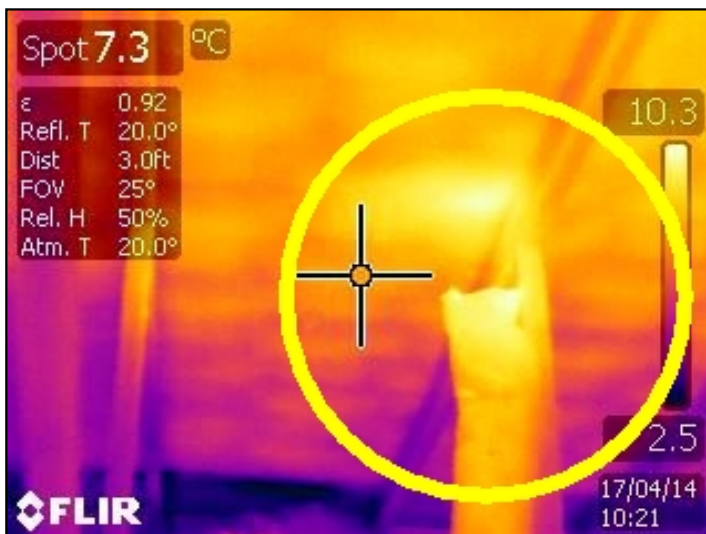
Page 26 Item: 6	Bathroom Exhaust Fan Condition	<ul style="list-style-type: none"> • Exhaust fan is vented into attic area - must vent externally
Page 29 Item: 14	Traps/Drains/Supply Condition	<ul style="list-style-type: none"> • Bathroom venting into attic - must vent externally
Page 29 Item: 15	Toilet Condition	<ul style="list-style-type: none"> • Toilet slightly loose. Recommend tightening to prevent water damage.

- All vent fans should be kept clean to function as correctly.
- Exhaust fan is vented into attic area - must vent externally

Venting into attic

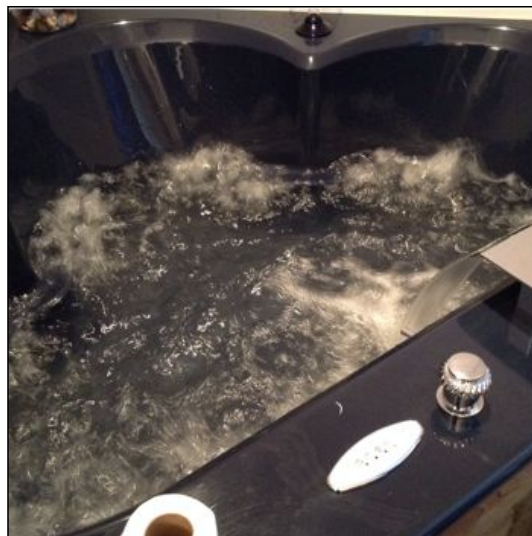
- Tub was partly filled to test, the home was thermally scanned for hidden leaks, none on day of inspection, we can not be held responsible for future leaks. Leaks can start at anytime.
- Whirlpool tub observed. Tub was filled to a level above the water jets and operated to check intake and jets. The tub was then drained to check for leaks and/or damage. Pump and supply lines were not visible or accessible. GFCI's were present and was tested. The items tested appeared to be in serviceable condition on the day of the inspection only.

Tested and worked as required

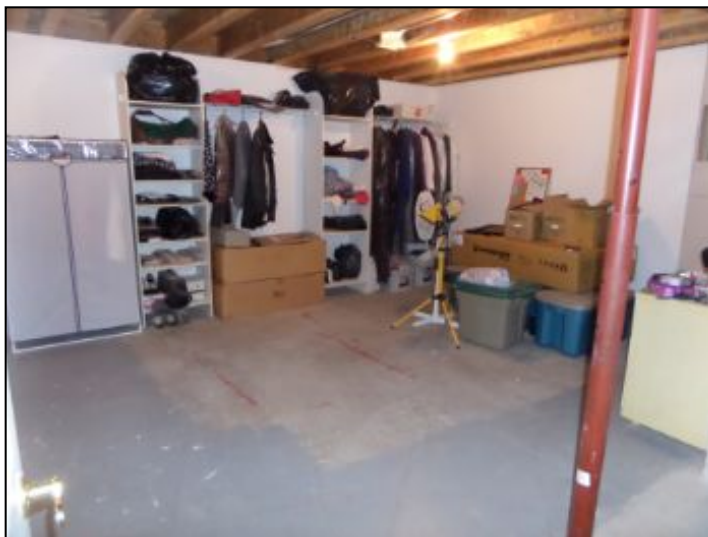
Furnace area

- Inaccessible areas behind insulation and vapour barrier are not within the scope of this report. Buyer is urged to review the sellers Property Information Sheet to determine if any issues such as seepage have occurred in past as this inspection is limited to visually accessible items only.
- Finished basement: finished areas in basement were observed. Access to the original basement walls, floors, and ceilings was not available due to the additional construction that is present such as framed out walls, covered ceilings, and added floor coverings. As these areas are not visible or accessible to the inspector they are excluded from this inspection.

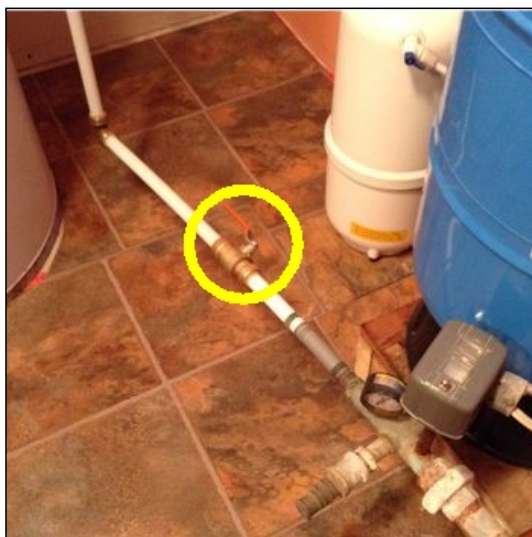
Water shut off to feed

- No leaks at the time of the inspection, ongoing monitoring of all plumbing suggested.

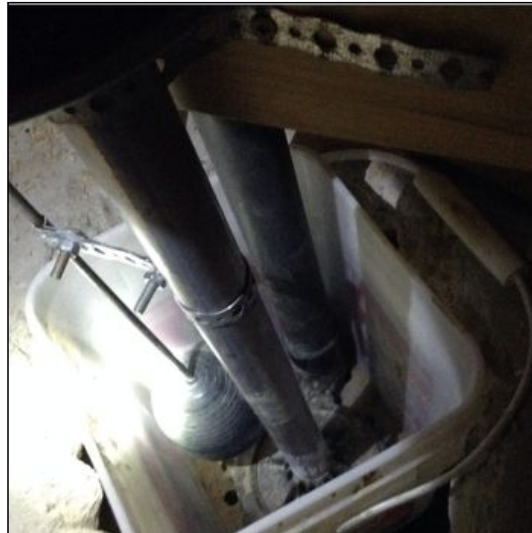
- Pit was totally dry on day of inspection.

Home made sump tested and worked as required

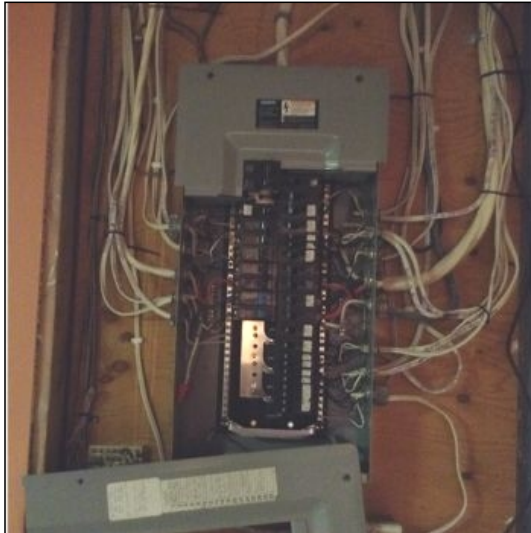
100 amp at store room panel

- The main service is approximately 100 amps, 240 volts.
- Open positions observed for future expansion.

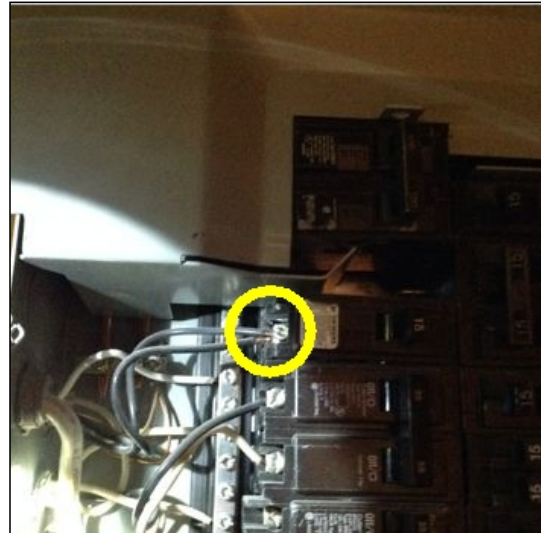
- All appeared good when inspected on the day of the inspection.
- Double tapping observed. Double tapping (i.e. 2 wires on a single pole breaker) can add to the load of the affected circuit causing a possible overload and tripping breakers, or result in loose connections and overheating of the breaker or connections. Ideally, doubled-up circuits should be independently fused.

Possible double tapping in store room panel - not the inspectors job to decide if the breaker is single or double pole

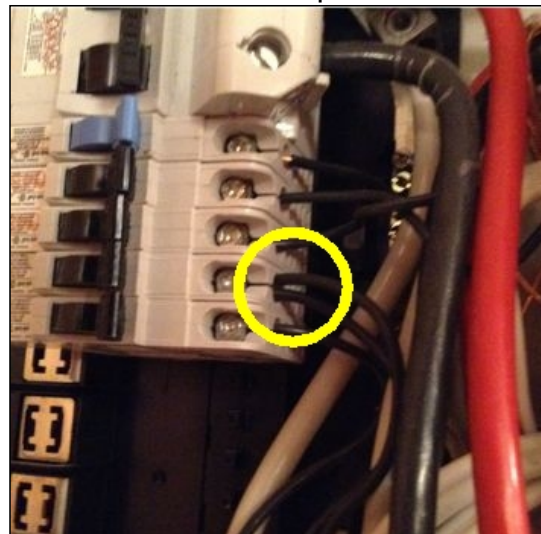
Double tapping in rec room panel

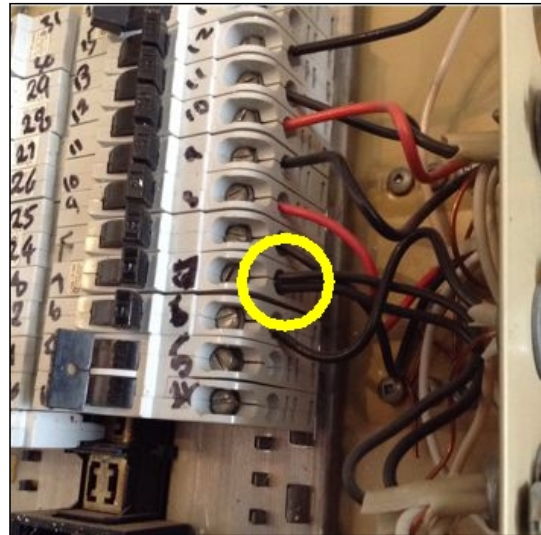
- Located in garage
- Double tapping observed at one position. Double tapping (i.e. 2 wires on a single pole breaker) can add to the load of the affected circuit causing a possible overload and tripping breakers, or result in loose connections and overheating of the breaker or connections. Ideally, doubled-up circuits should be independently fused.

Double tapping in garage sub panel

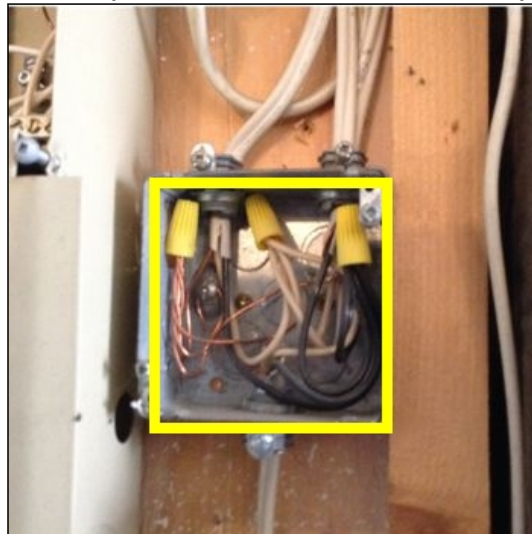
Close open junction boxes

- All electrical issues within the home should repaired/replaced buy a professional electrician, do not attempt repairs unless fully qualified.
- **Open junction boxes were observed, which is a safety concern. Recommend installing proper covers, as needed, for safety.**

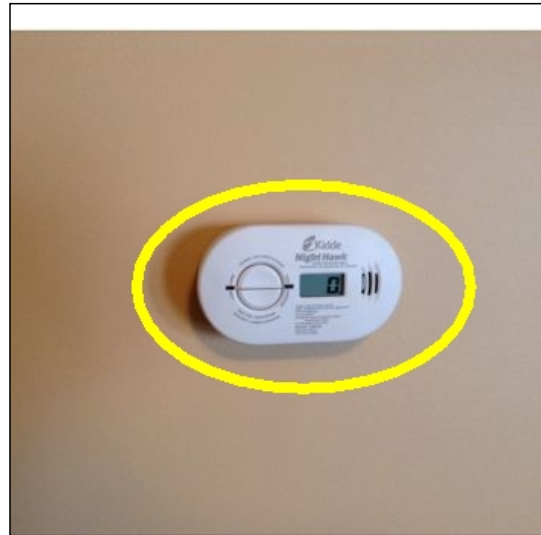
Carbon monoxide detector in place

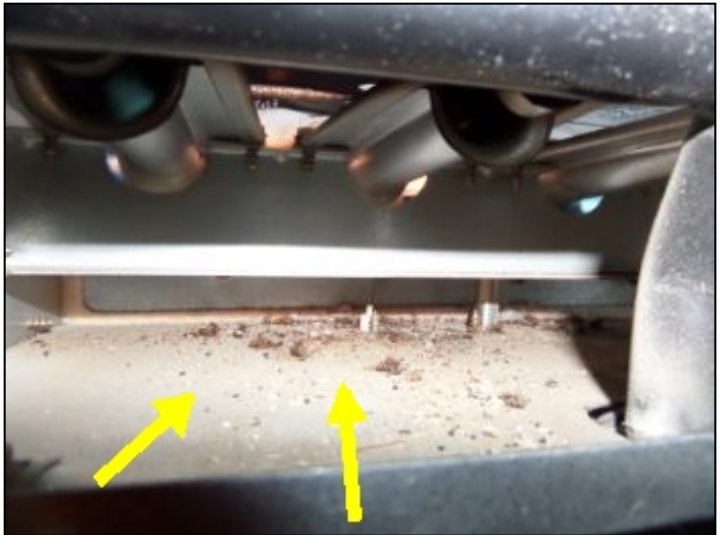
- No record of recent service observed, suggest full clean and service on possession then every 2 years.
- Due to presence of rust, scale, and some debris in this appliance, a service review by a licensed HVAC contractor is advised to ensure proper and safe operation of this unit. Inspection for holes and/or cracks in heat exchangers is not within the scope of this inspection and should be performed prior to closing to ensure the proper and safe operation of the system.

Full clean and service required

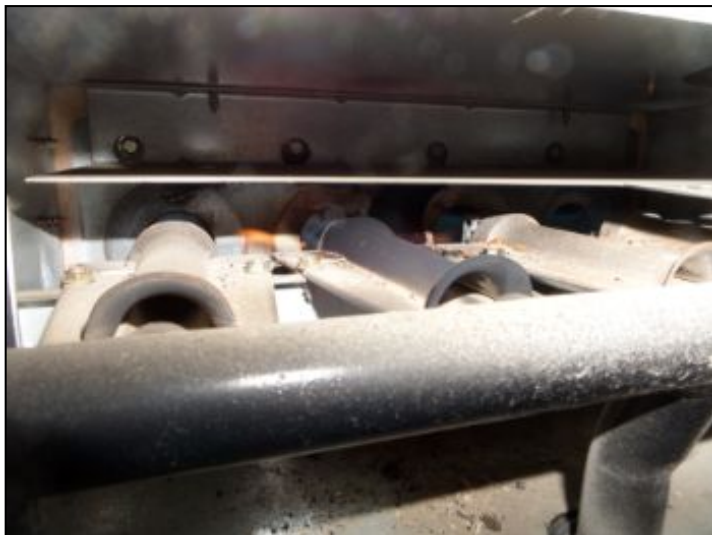
- The presence of soot, carbon, or yellow flame indicates improper combustion may be occurring with this appliance. This is a "Safety Concern". Further review by the local utility company or licensed heating contractor is recommended prior to closing to ensure safety.

Flame not even - possibly problem - hvac engineer to inspect

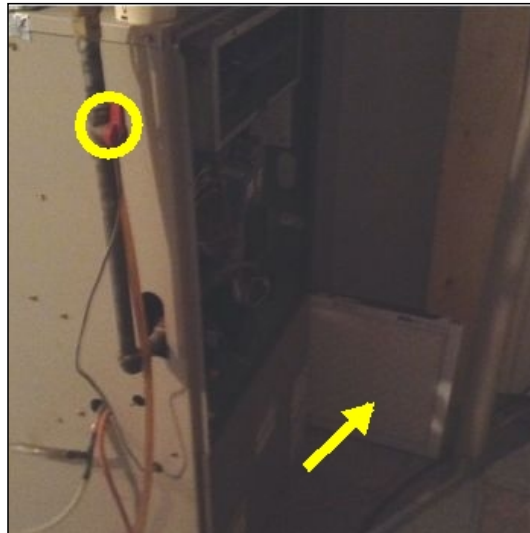
Gas shut off to furnace - replace filter every 2-3 months

- Suggest filters are changed every 2-3 months, unless otherwise stated by the filters manufacture.

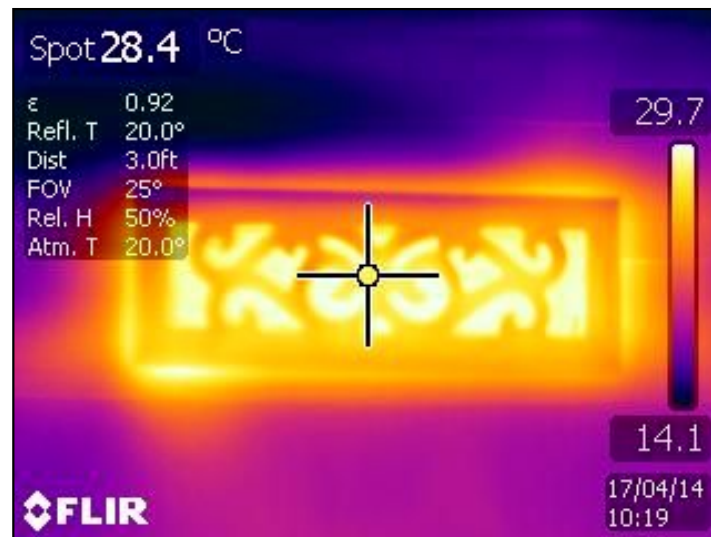
- All heat registers are tested using thermal imaging to ensure they are operating consistently as required.

Heating tested and worked as required

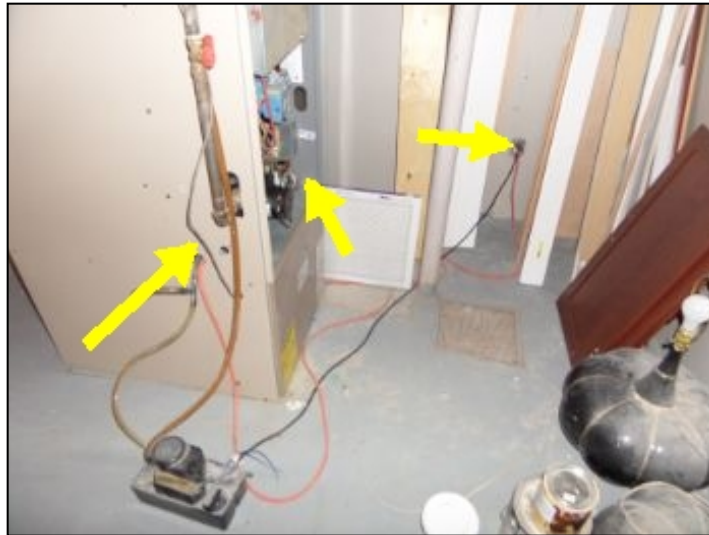
No kill switch for furnace and powered with extension cord

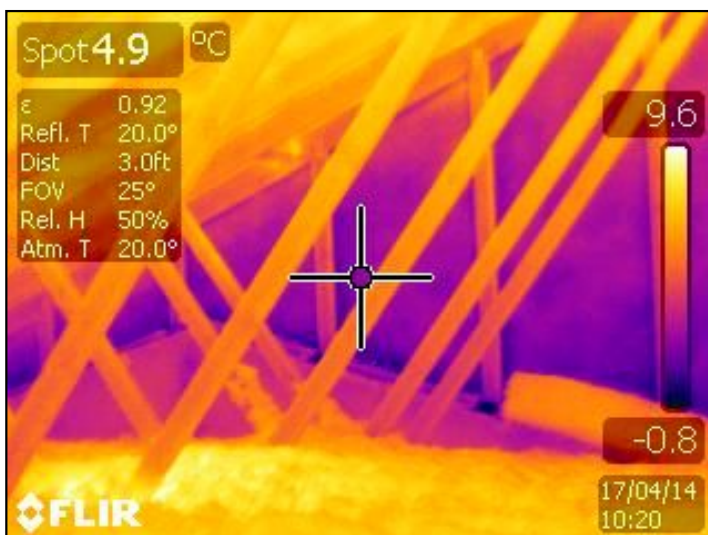
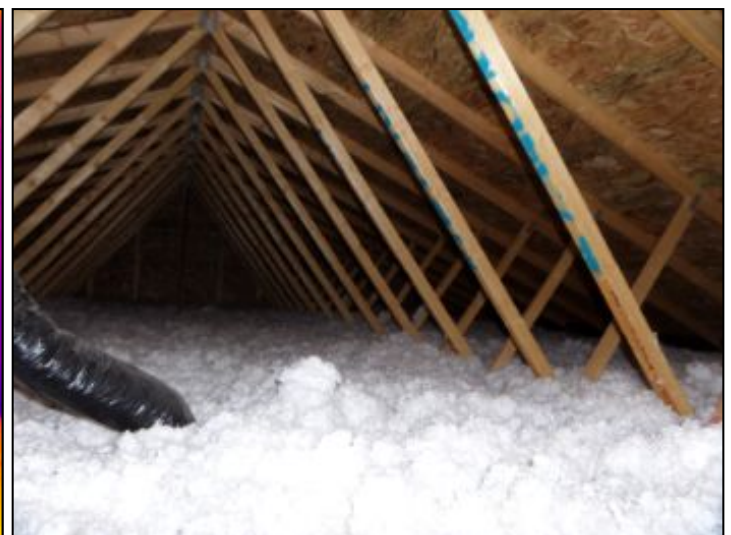
All good in attic on day of inspection

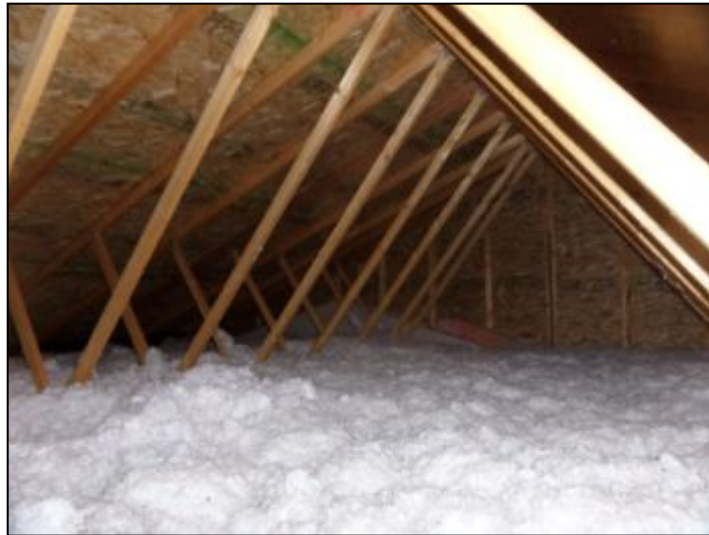
All good in attic

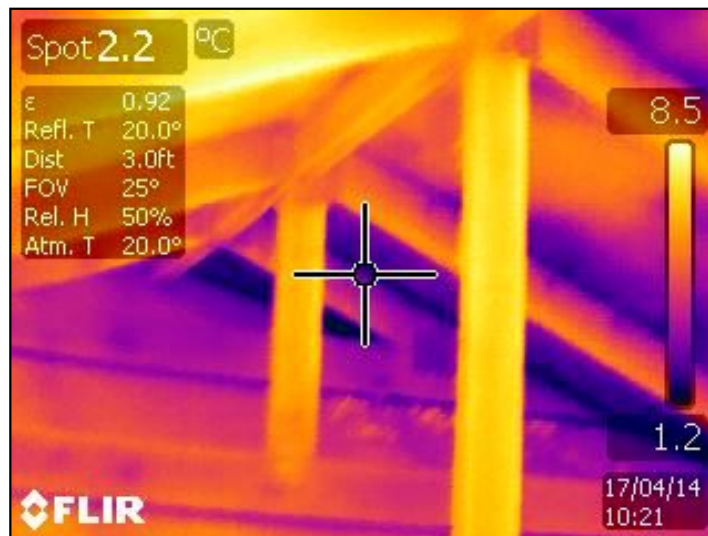
- The attic space was visually inspected and Infrared thermally scanned, it all appeared dry on the day of the inspection. (we can only comment on what is visible and assessable from the attic hatch at the ladders edge)

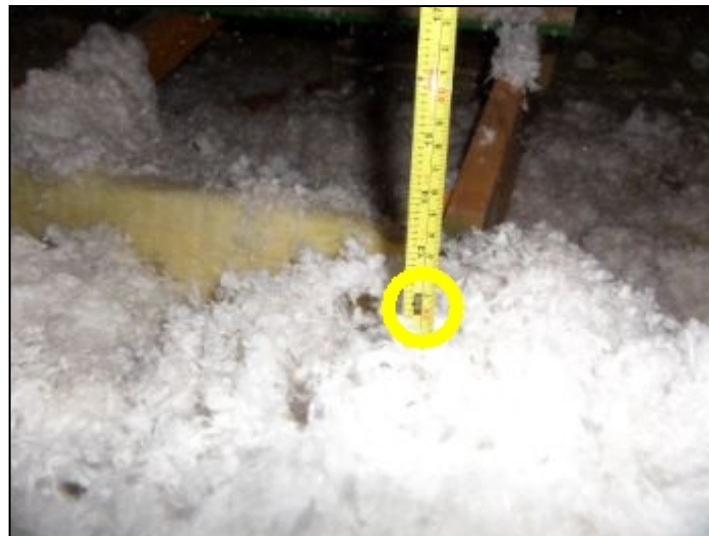
Approx 12 inches noted
