YOUR INSPECTION REPORT

123 Sample Drive S.E.
Calgary, AB

Tuesday, July 24, 2012

RE: Report No. 1004, v.4
123 Sample Drive S.E.
Calgary, AB

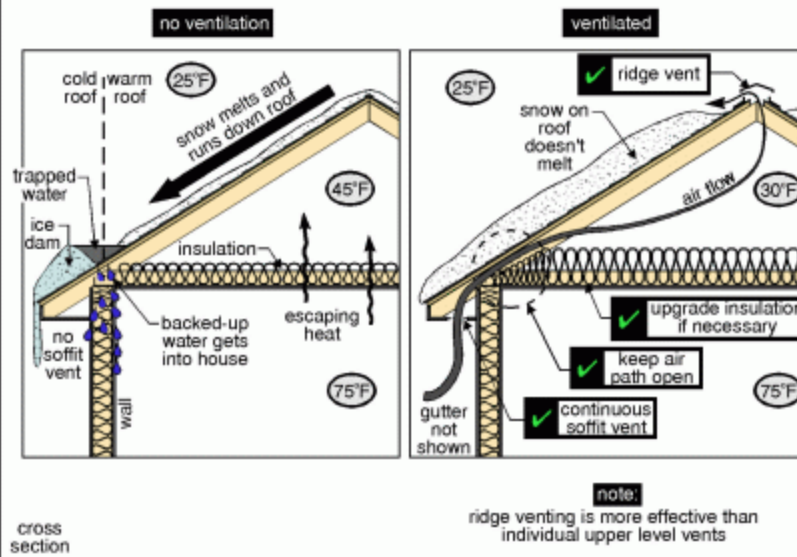
Preventing ice dams with ventilation

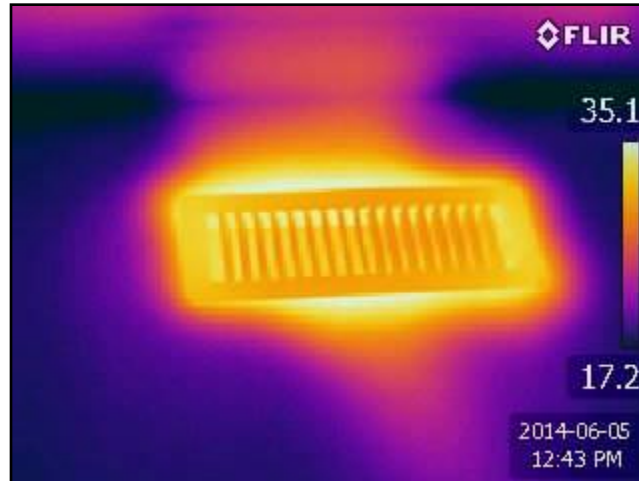
9. All heat registers are tested using thermal...

General: • All heat registers are tested using thermal imaging to ensure they are operating consistently as required.
